A/5069/Add.1
24 April 1962

REPORT OF THE COMMISSION OF INVESTIGATION INTO THE CONDITIONS AND
CIRCUMSTANCES RESULTING IN THE TRAGIC DEATH OF MR. DAG HAMMARSKJOLD
AND OF MEMBERS OF THE PARTY ACCOMPANYING HIM*

ANNEXES

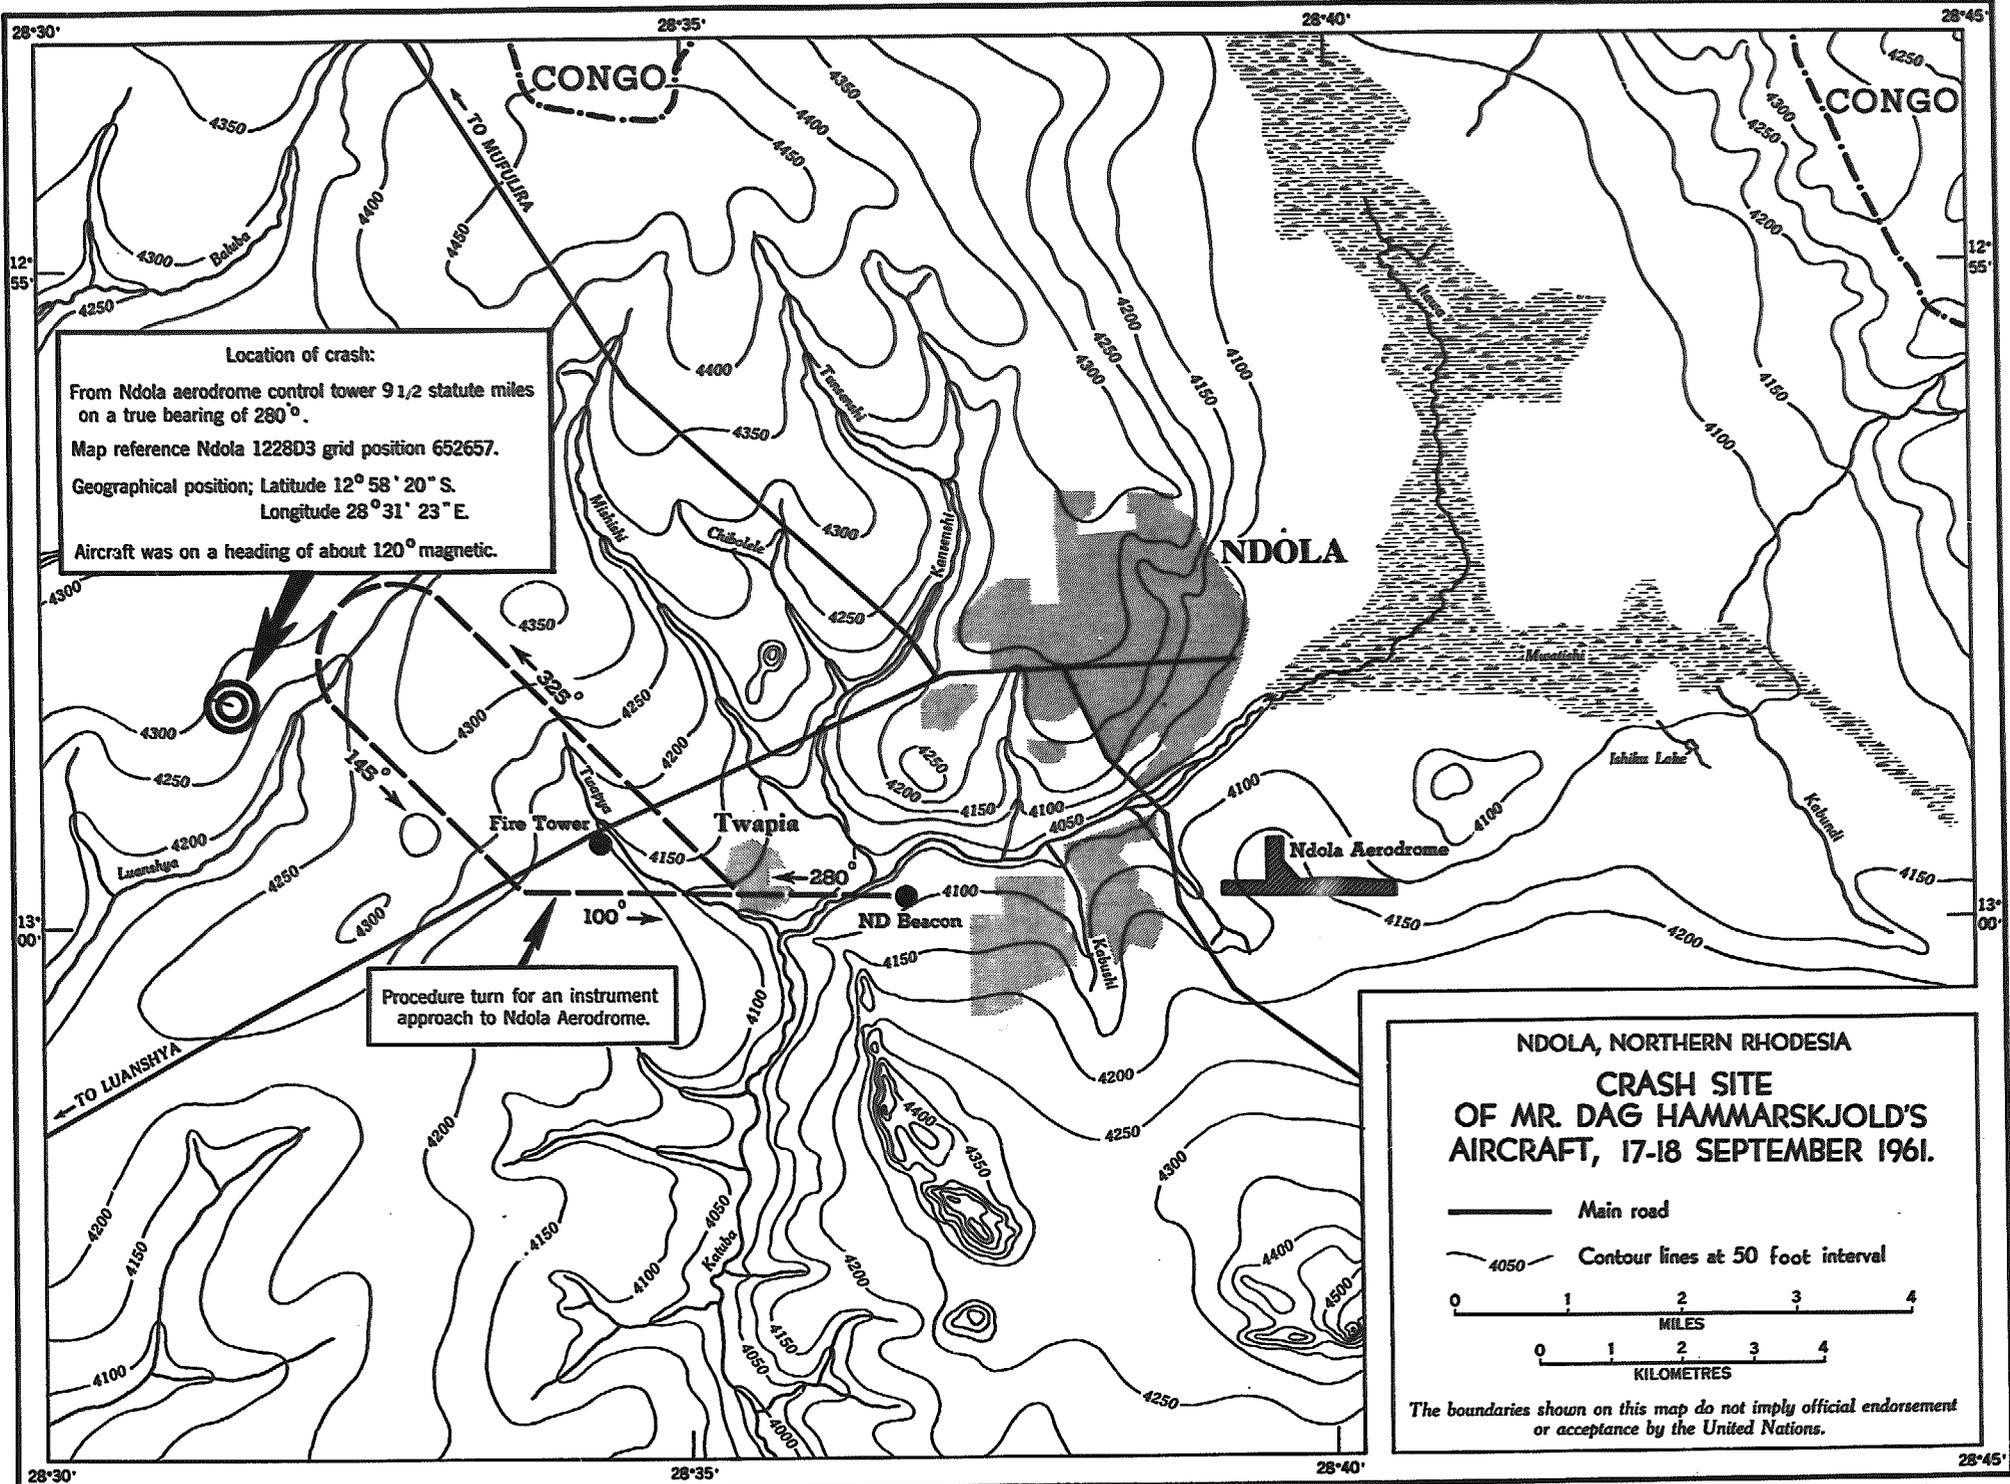
Ndola chart superimposed on map of Ndola area
showing crash site

Location of crash:
 From Ndola aerodrome control tower 9 1/2 statute miles
 on a true bearing of 280°.
 Map reference Ndola 122803 grid position 652657.
 Geographical position; Latitude 12° 58' 20" S.
 Longitude 28° 31' 23" E.
 Aircraft was on a heading of about 120° magnetic.

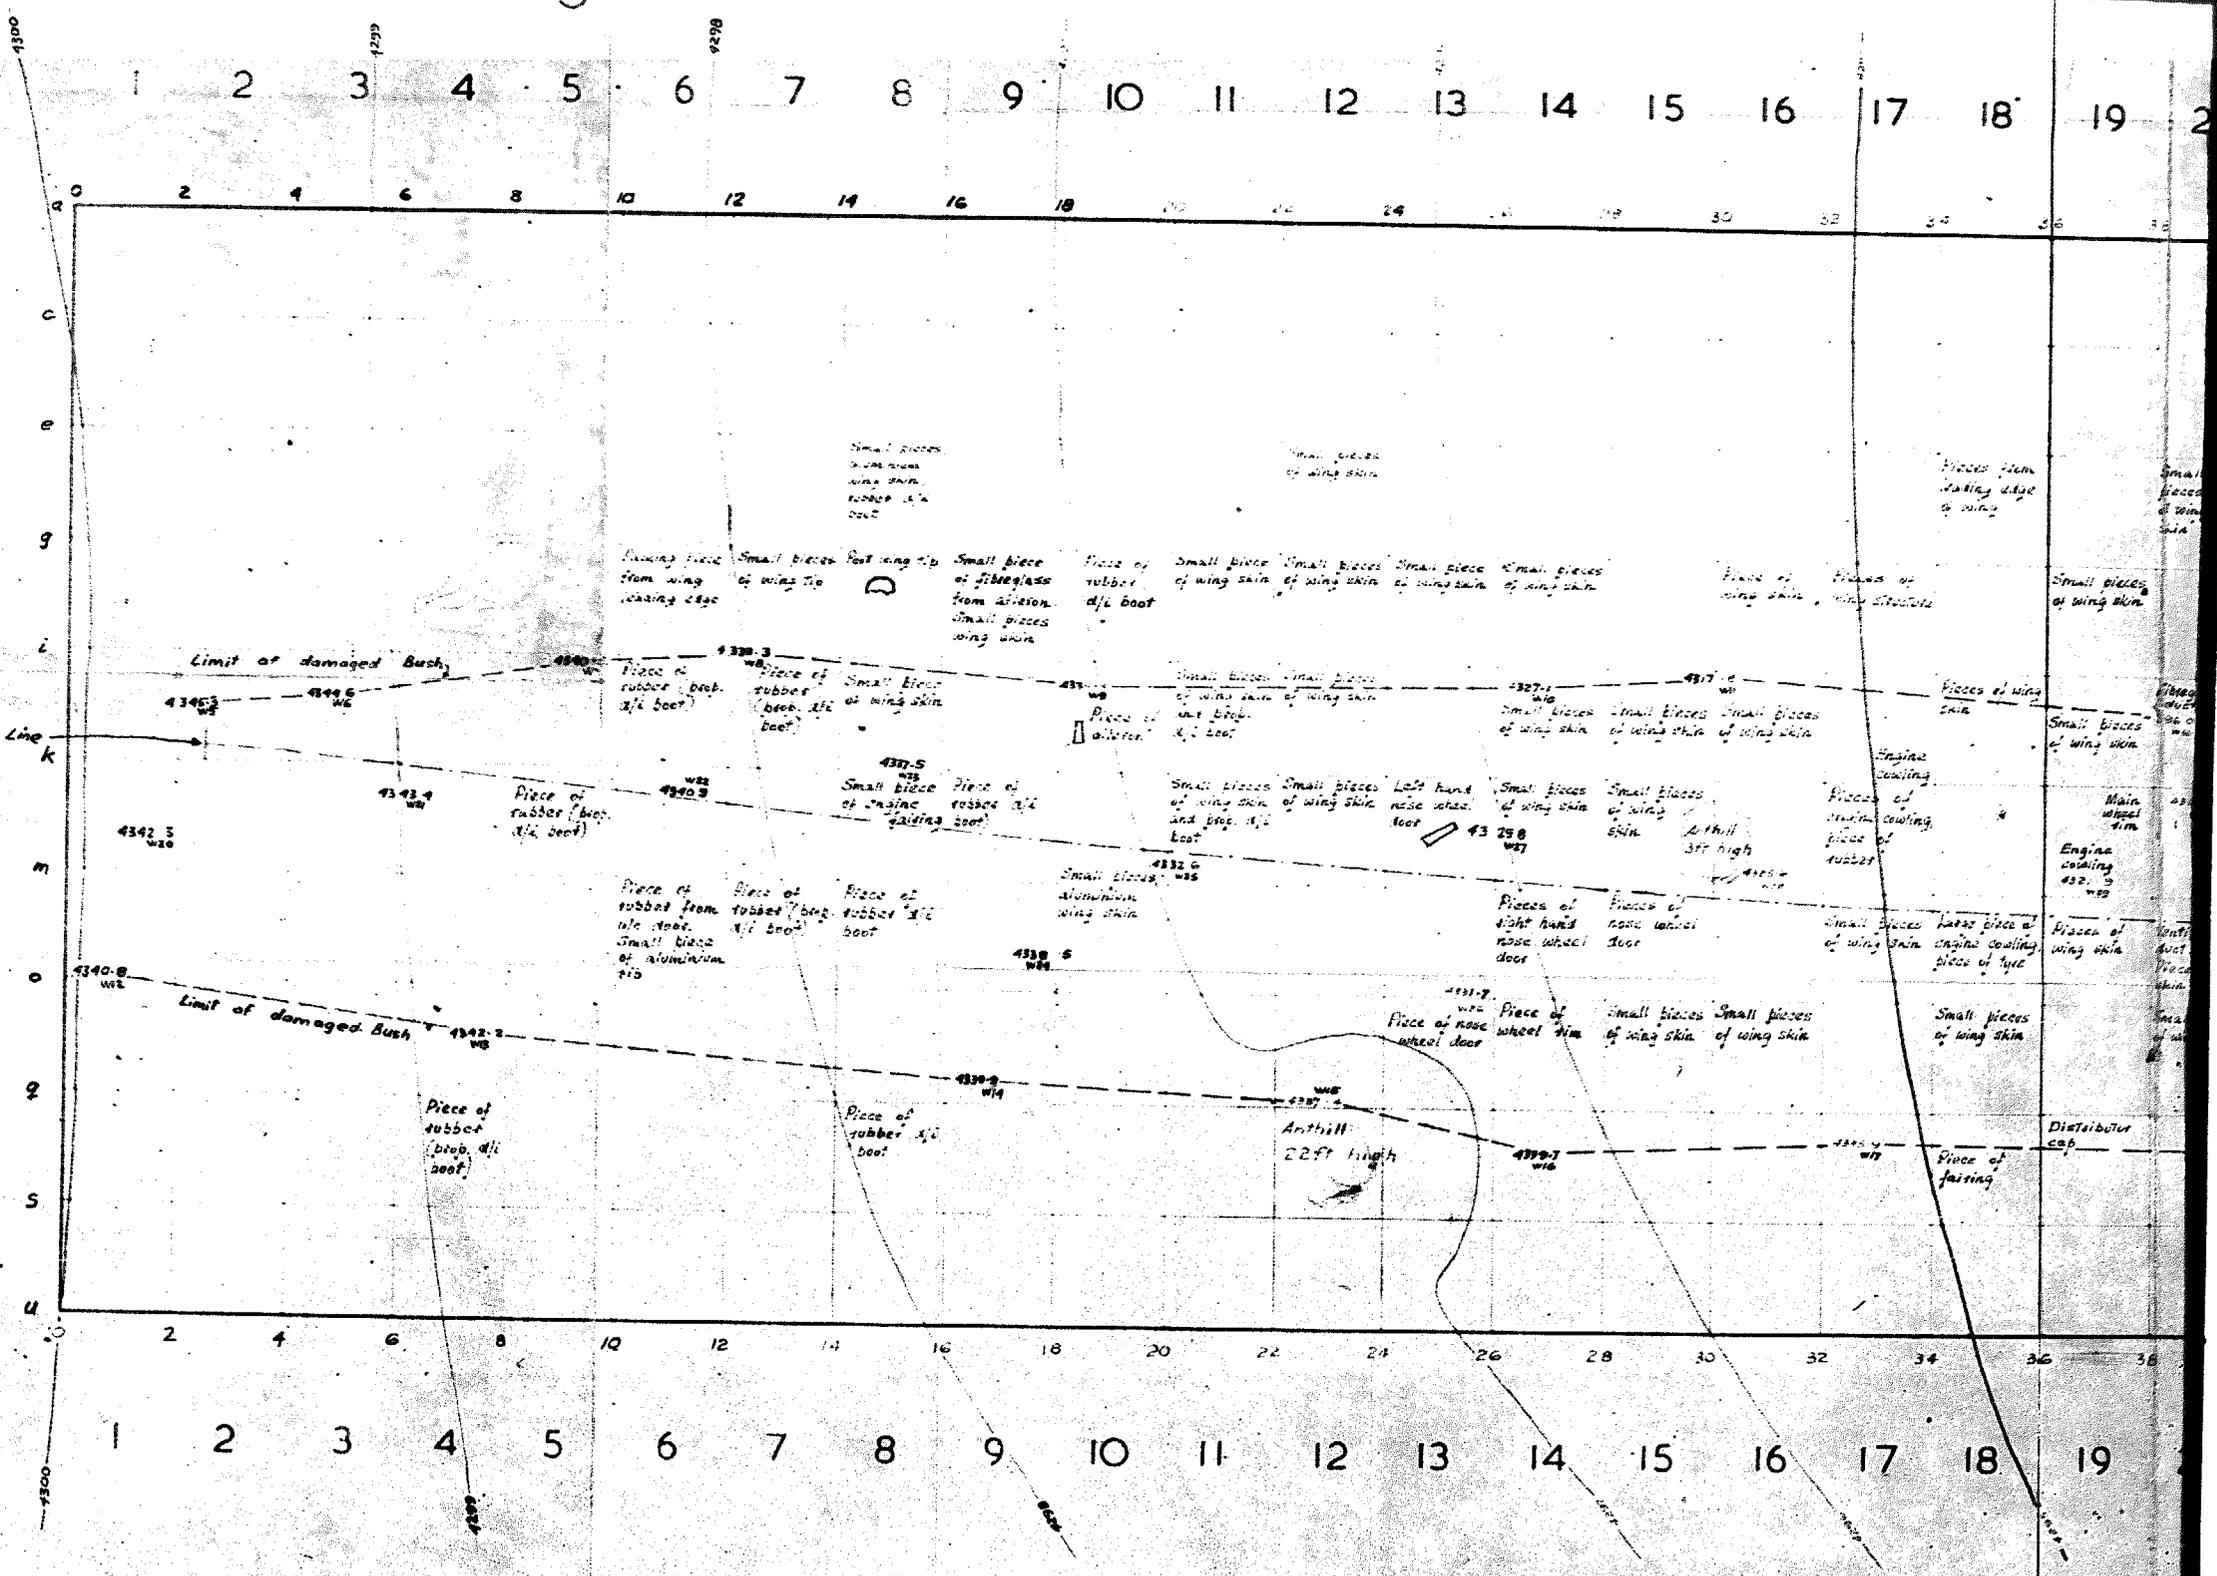
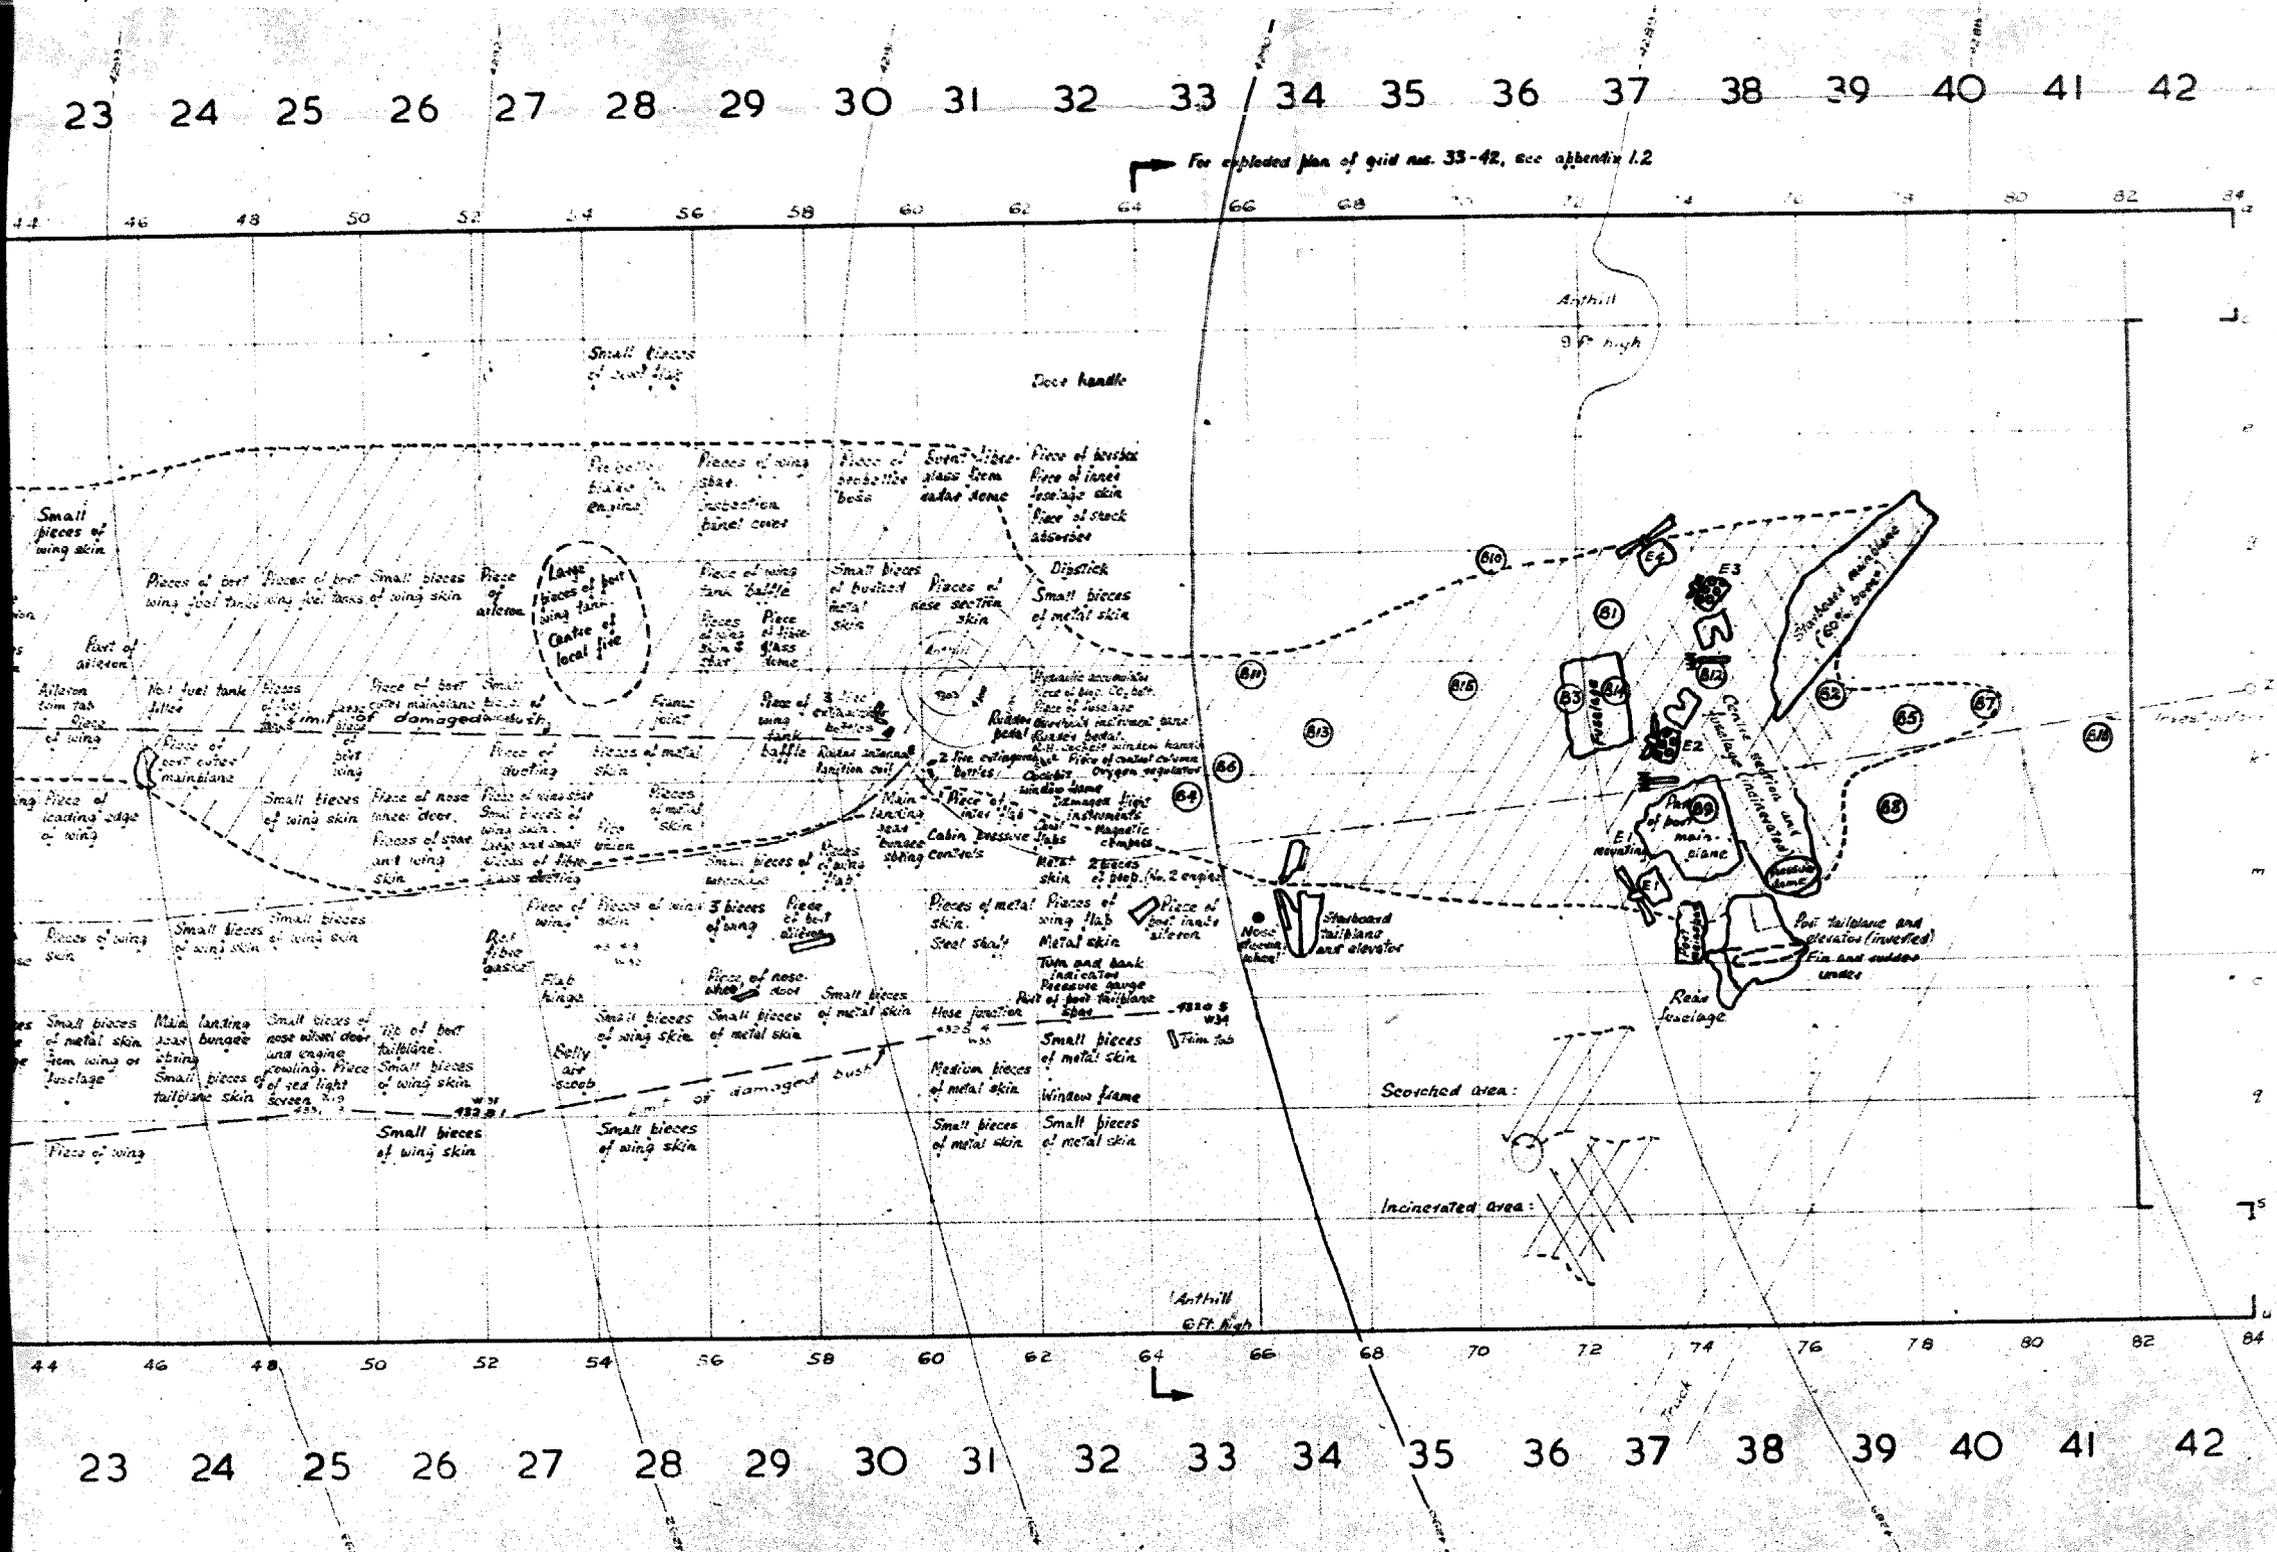
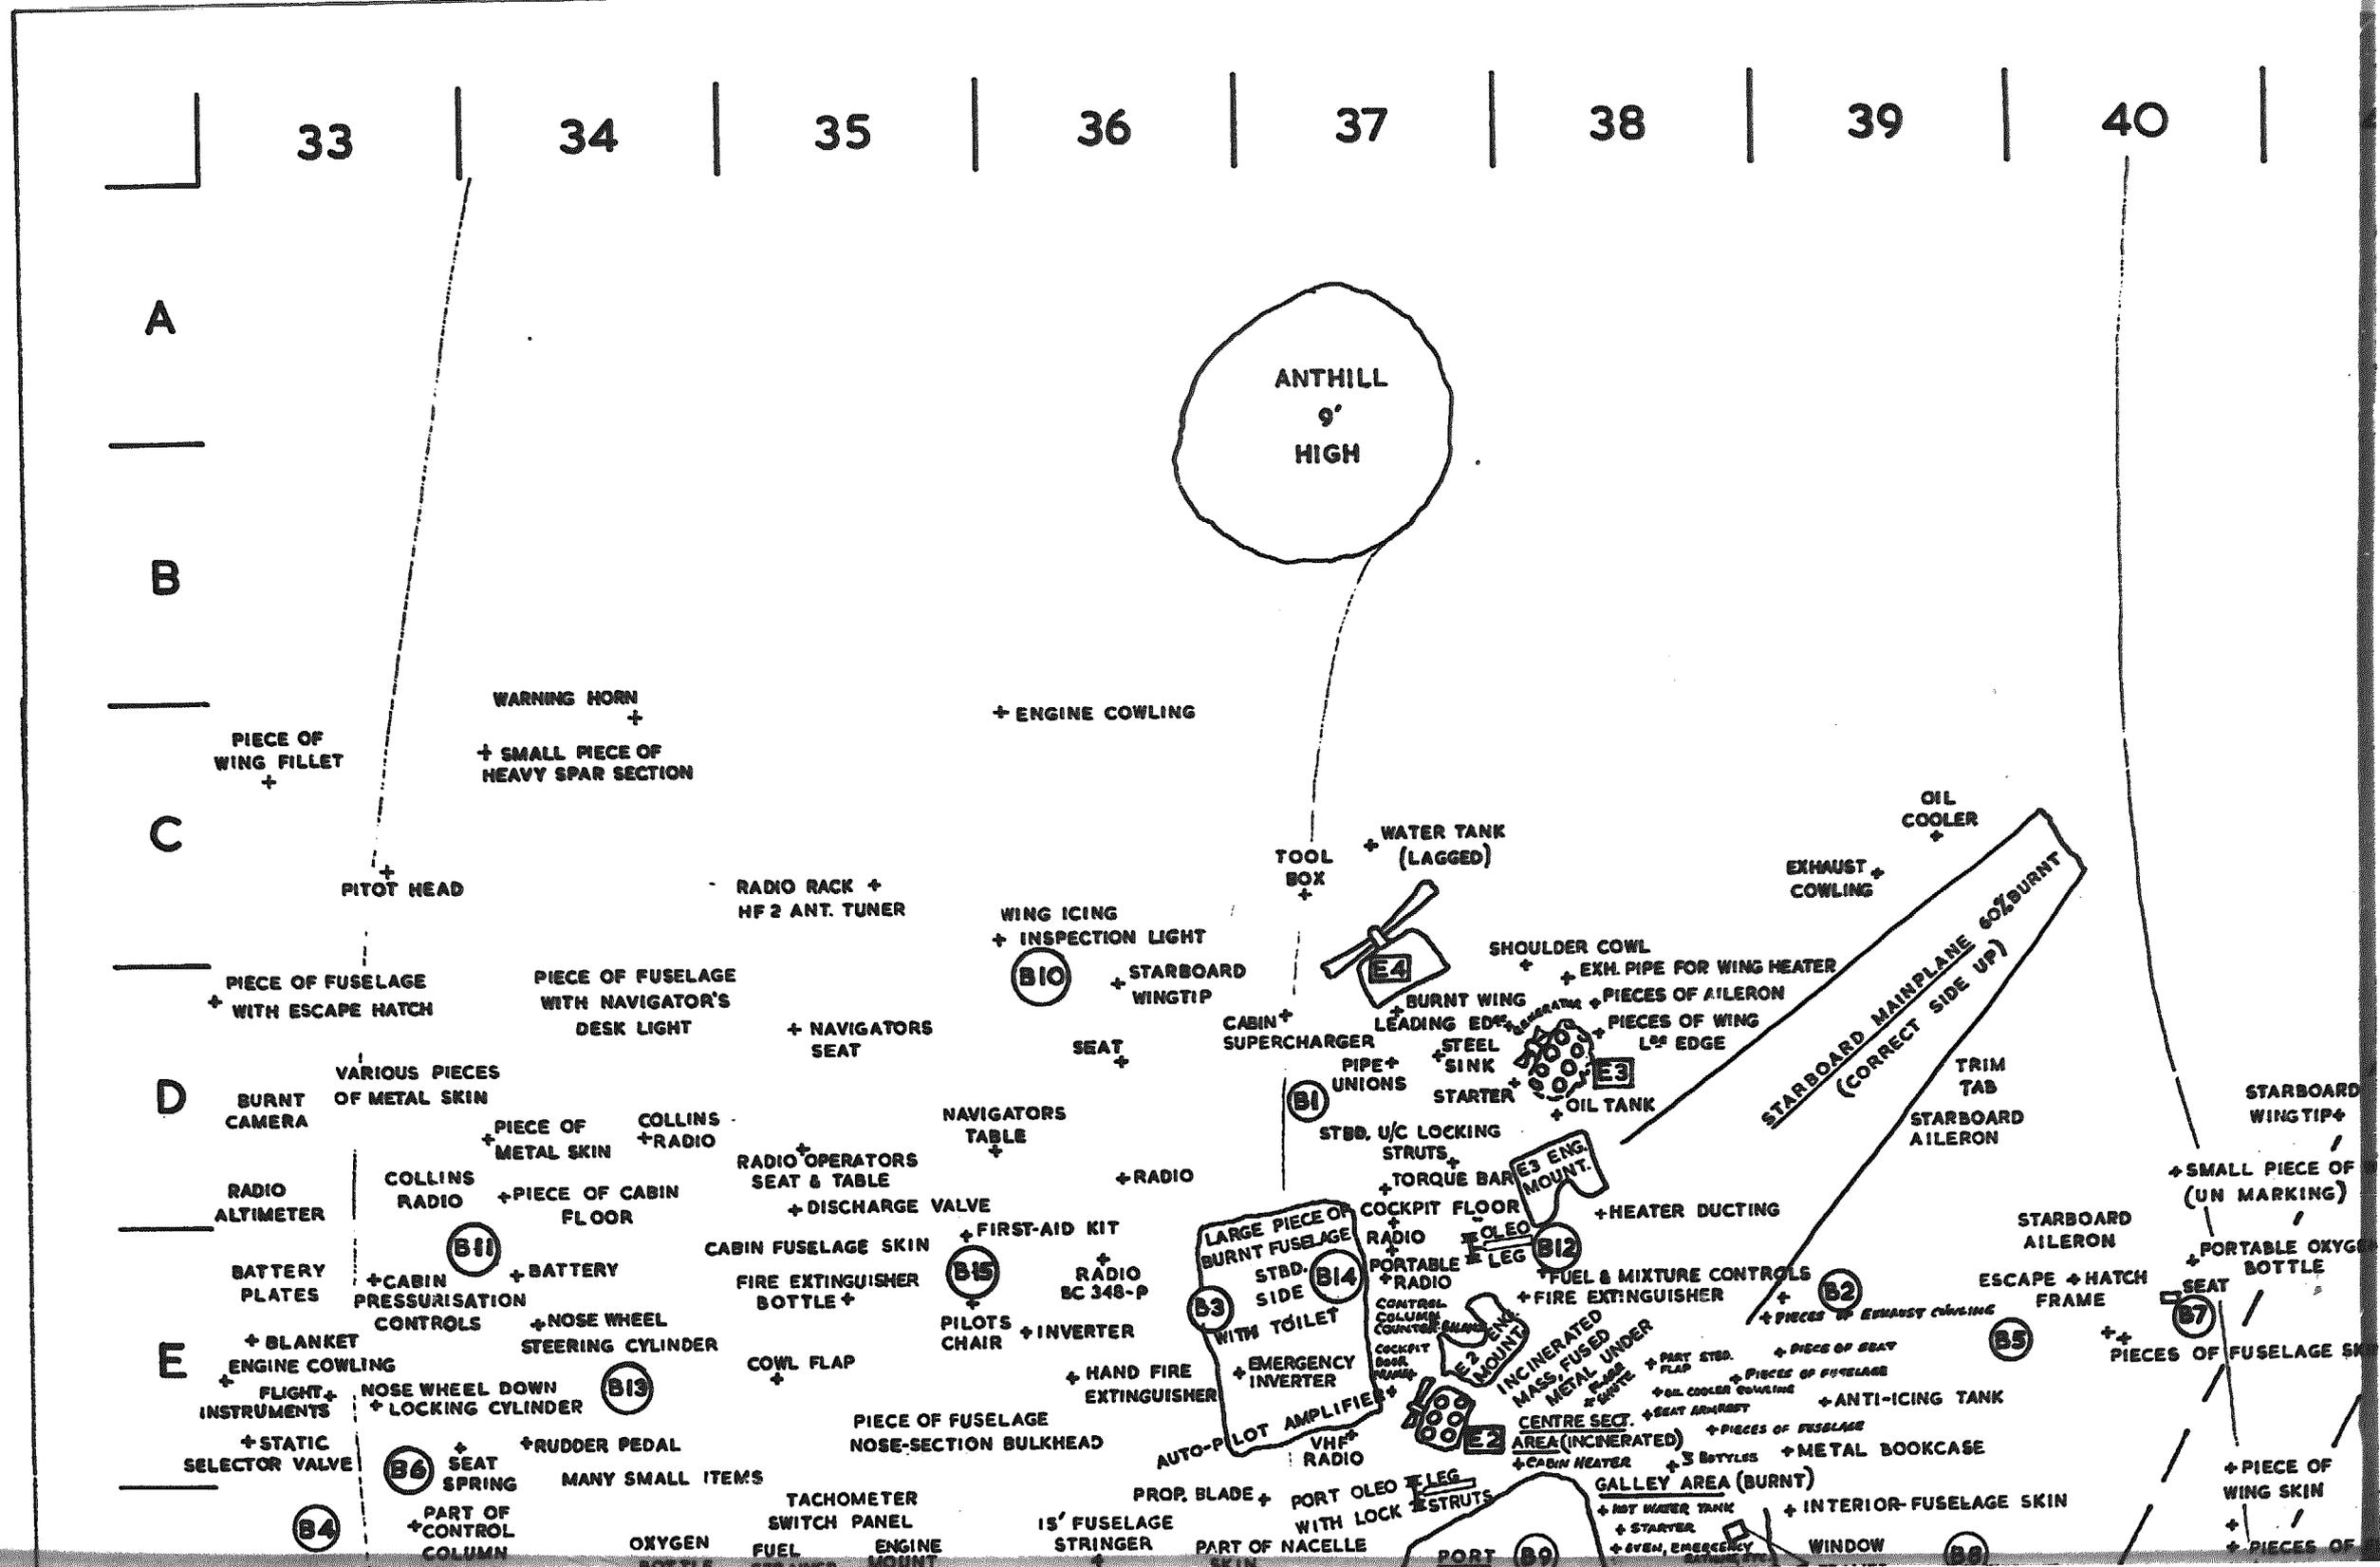
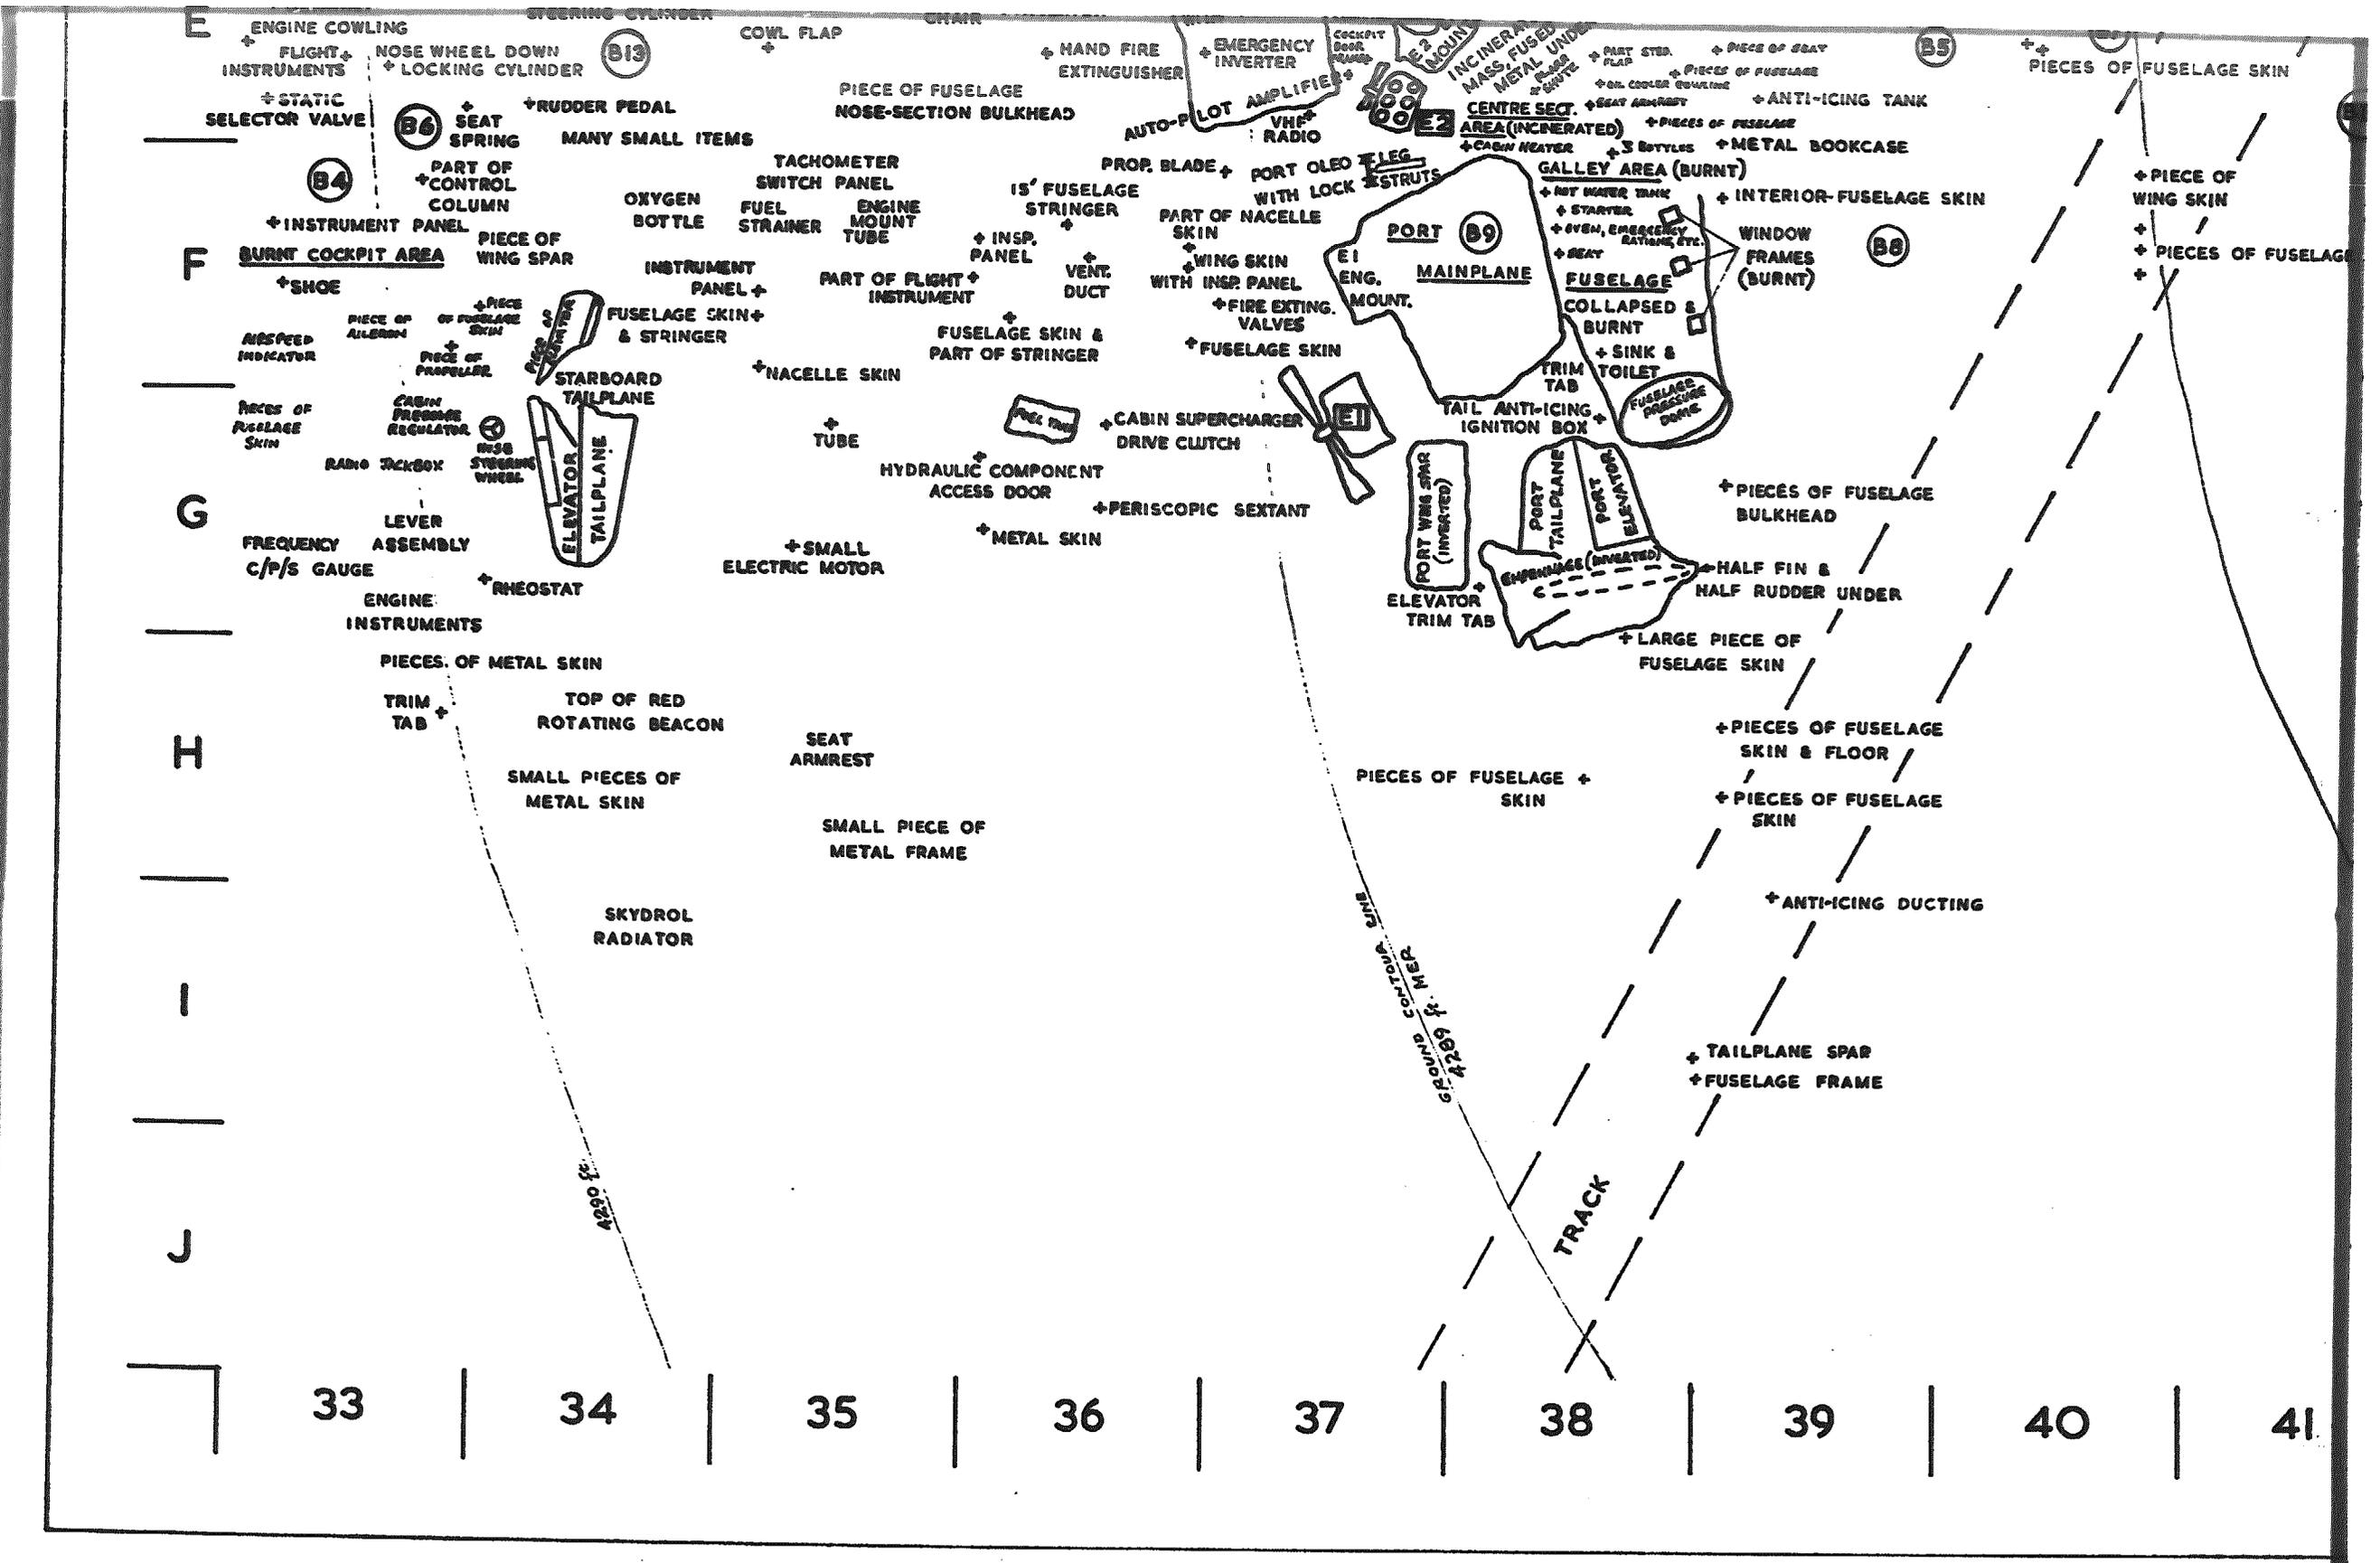
- A. Wreckage plan (scale 1 inch to 30 feet)
- B. Enlarged wreckage plan

10.2.1 The main wreckage was contained in an area approximately 60 feet by 90 feet and its disposition is shown on the wreckage plan at appendices 1.1 and 1.2. With the exception of the empennage, the fuselage aft of the rear pressure dome, and the left hand outer (No. 1) engine, the whole of the concentrated main wreckage was badly damaged by fire. The photographs at appendix 1.9 show the extent of destruction. The wing assembly, comprising left and right inner sections and right hand outer, came to rest correct side uppermost and had been attached to fuselage and power plants prior to impact. The right hand wing and flying control surfaces were badly damaged by impact and this occurred as the wing fell on to the trees in a vertical movement. The empennage was inverted with upper halves of the vertical stabiliser and rudder broken off, the complete right hand stabiliser and elevator were also detached. The left hand inner (No. 2) and the right hand inner (No. 3) engines, together with their respective propellers and nacelles were extensively incinerated. The fuselage nose section including the cockpit was broken up and scattered in an area centred approximately 100 feet before the nearest part of the main wreckage. The fuselage forward of the rear pressure dome was completely destroyed by impact and subsequent fire, the seats, interior fittings and galley equipment being scattered over a wide area. The landing gear assemblies were located in the main wreckage. The left hand wing tip was recovered some 600 feet from the main wreckage, parts of the left hand outer wing being

10.3.2 All items of the wreckage were examined at the site for unusual features, relevant settings were recorded where applicable and the parts marked or labelled with the grid reference in which they had been found. The position of all significant parts of the wreckage are plotted on the Wreckage Plan at appendices 1.1 and 1.2

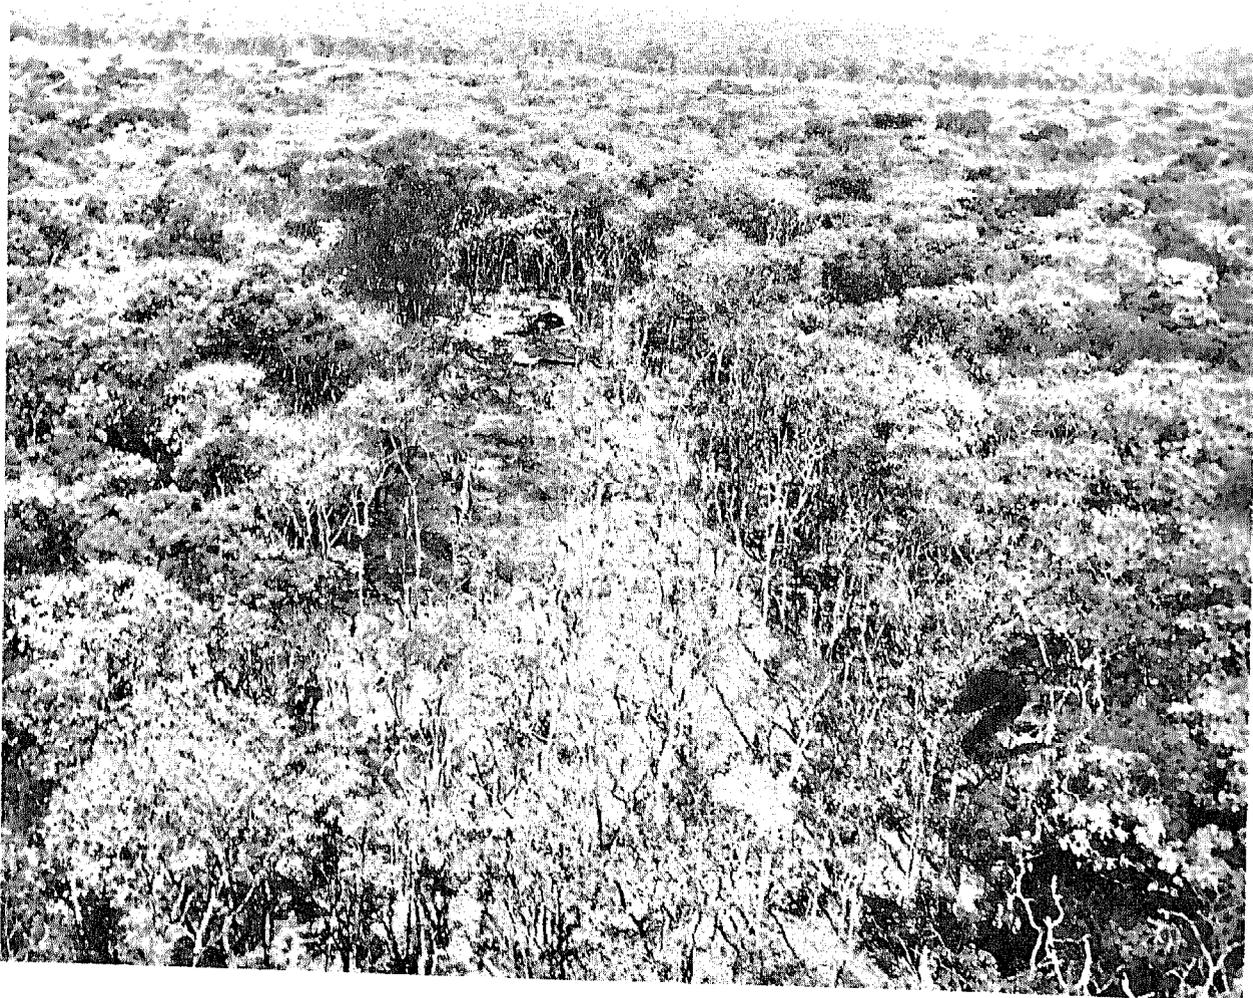
2. View of wreckage and approach path from direction of approach.

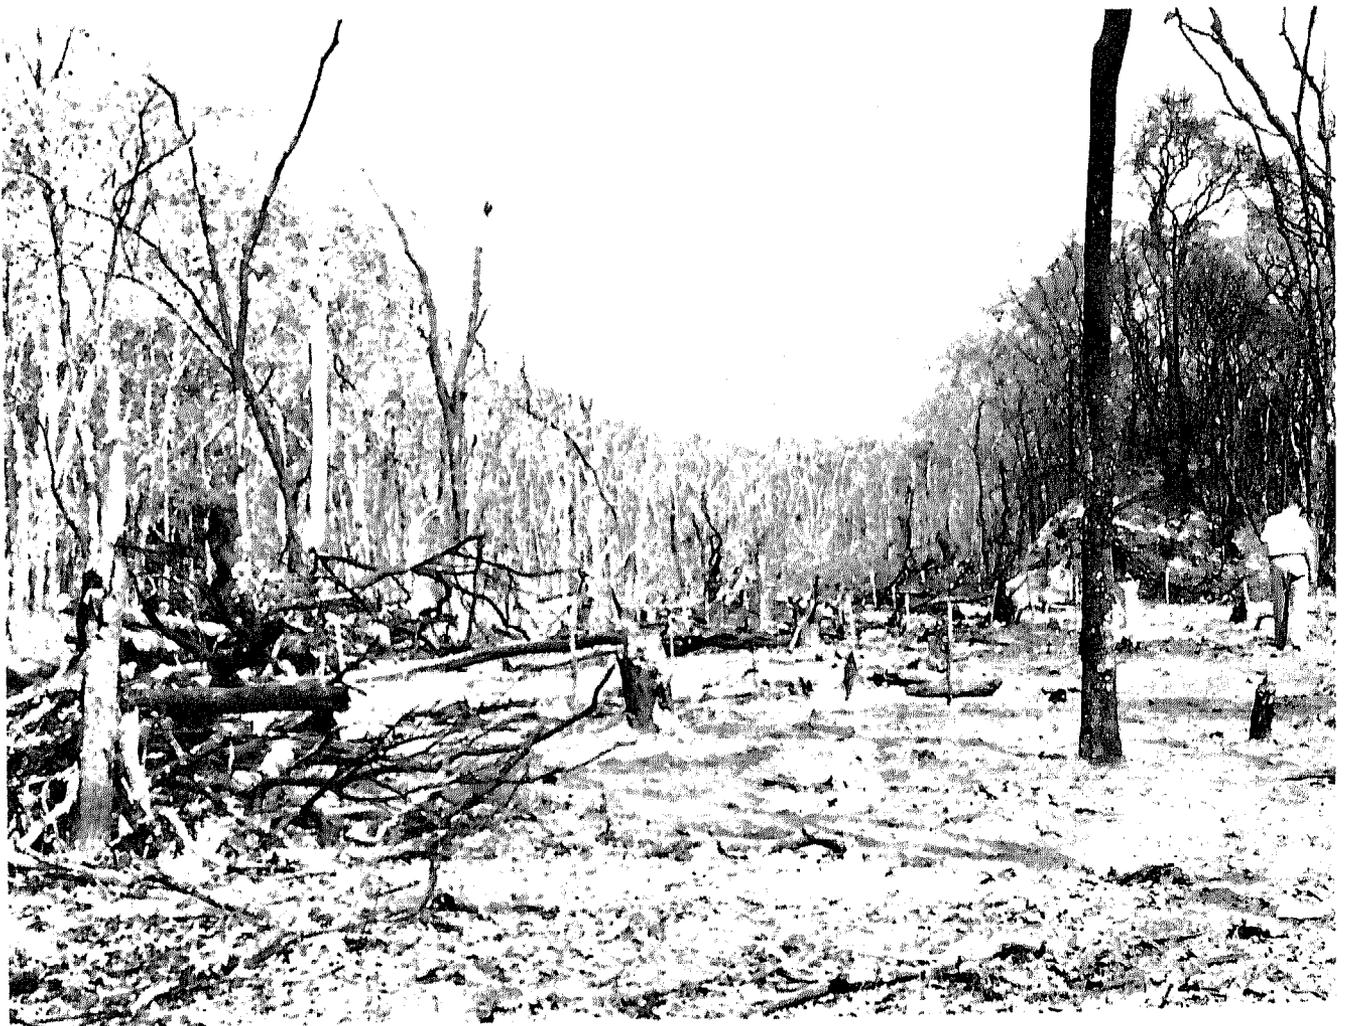
3. View of crash site (after clearance of wreckage) from ground looking back along line of approach. Main wreckage lay immediately behind the camera.

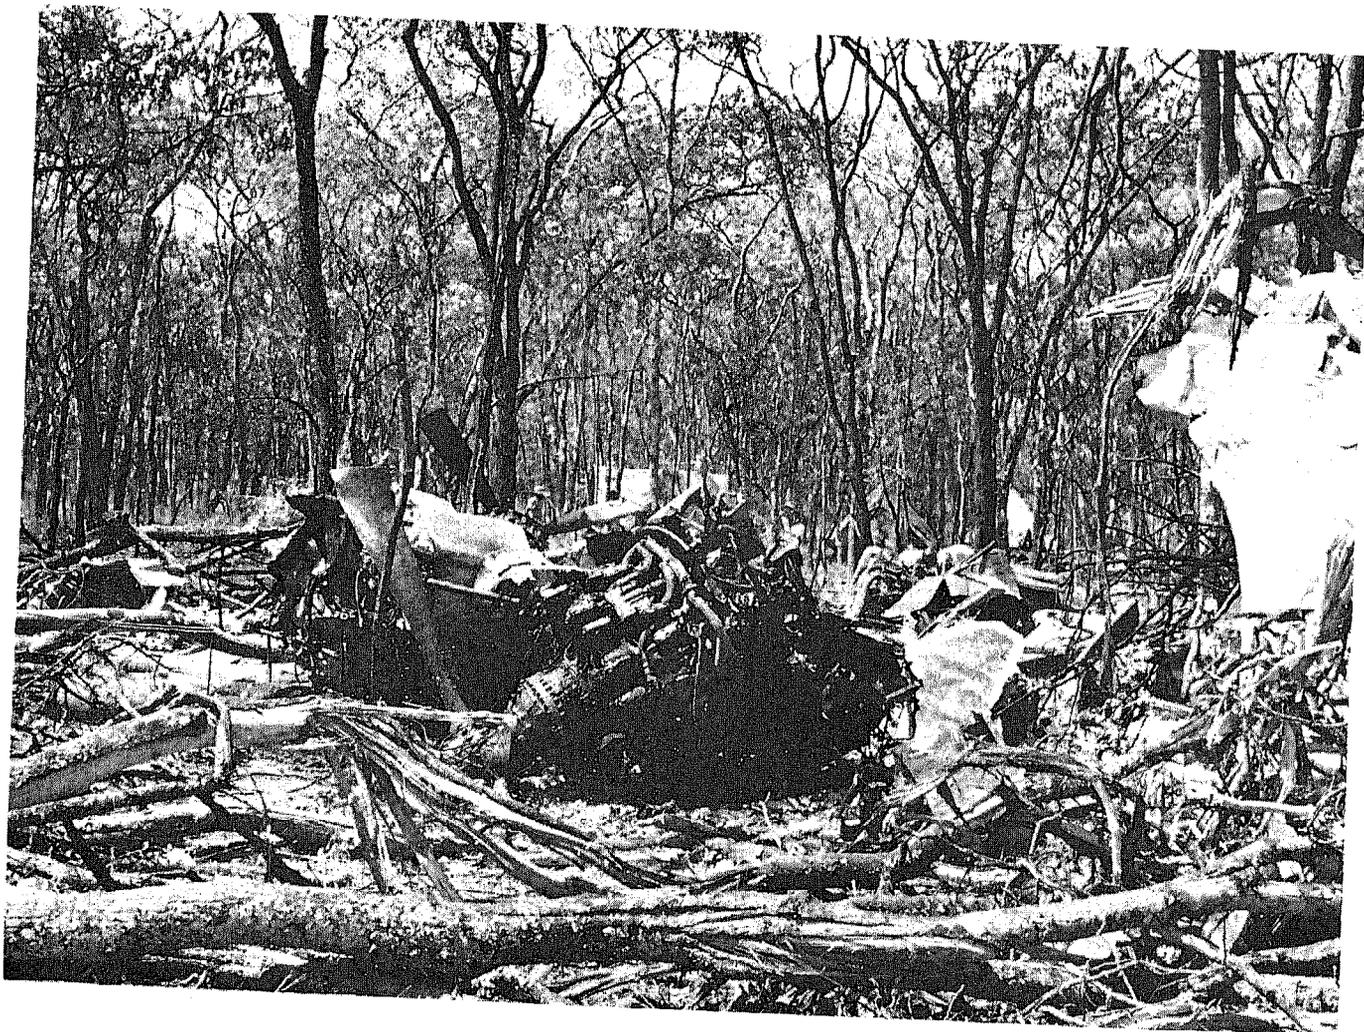
4. View of wreckage.
