# 安全理事会

### 事实调查组关于在阿拉伯叙利亚共和国的杜马发生的将有毒化学品用作武器的指称事件（2018 年 4 月 7 日）的报告

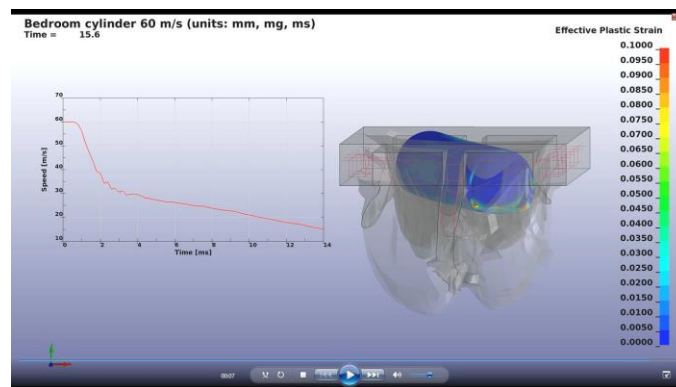
图 10: 缺口和气罐撞击的计算机调变

- 8.31 分析表明：第 2 号地点的钢筋混凝土平台遭受的结构性损坏是由物体撞击所致，该物体具有对称的几何形状，并具有足以造成观察到的损坏的动能。分析结果显示：所观察到的位于屋顶平台的气罐、缺口、阳台、周围房间、下方的房间和上层的结构遭受的损坏均符合该地点所见的气罐在平台上新造成的缺口的大小。

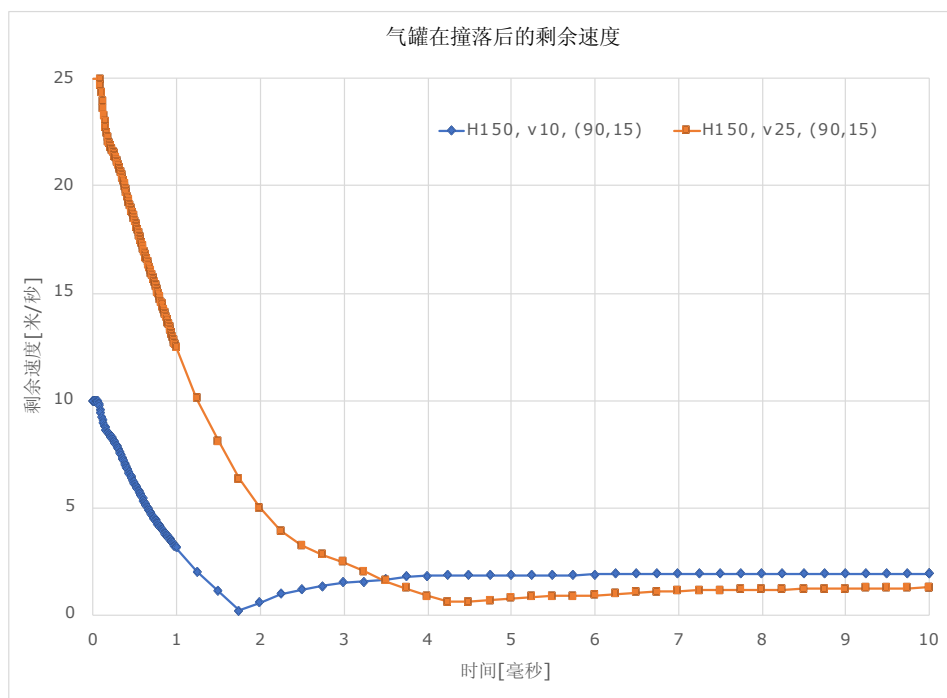
图 12：用以显示气罐可能的低速移动的图表

8.34 调查组咨询了机械工程、弹道学和冶金学方面的专家，以请他们对为气罐的轨迹进行称职和胜任的评估。评估的结果表明：在调制下生成的缺口的形状与视察组观察到的形状和损坏情况吻合。评估进一步显示：在穿透屋顶并以低速撞到地板上后，气罐继续改变了滚动轨迹，直至滚到了其被发现的位置。

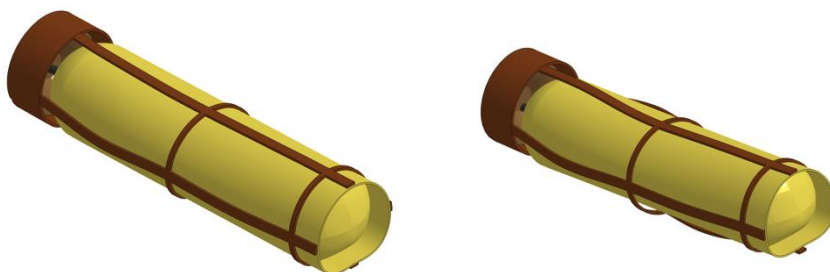
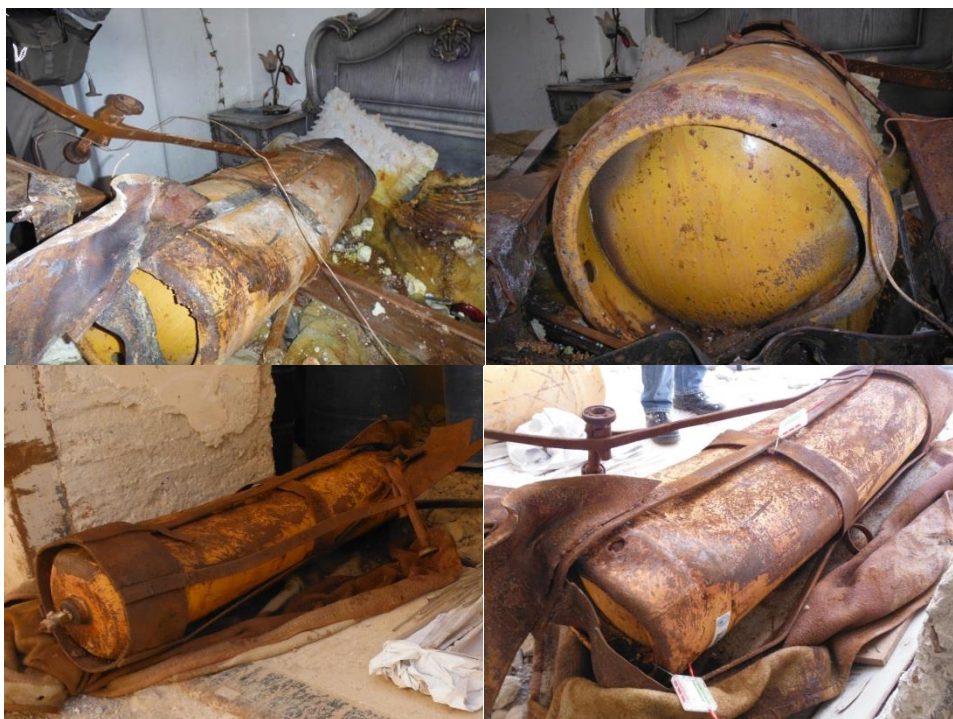
- 8.35 事实调查组采用类似的方式，评估了气罐上的结构性损毁与钢筋混凝土屋顶（据称气罐由此横贯而下）遭受的结构性损坏是否一致。图 13 和 14 显示了有关结论。

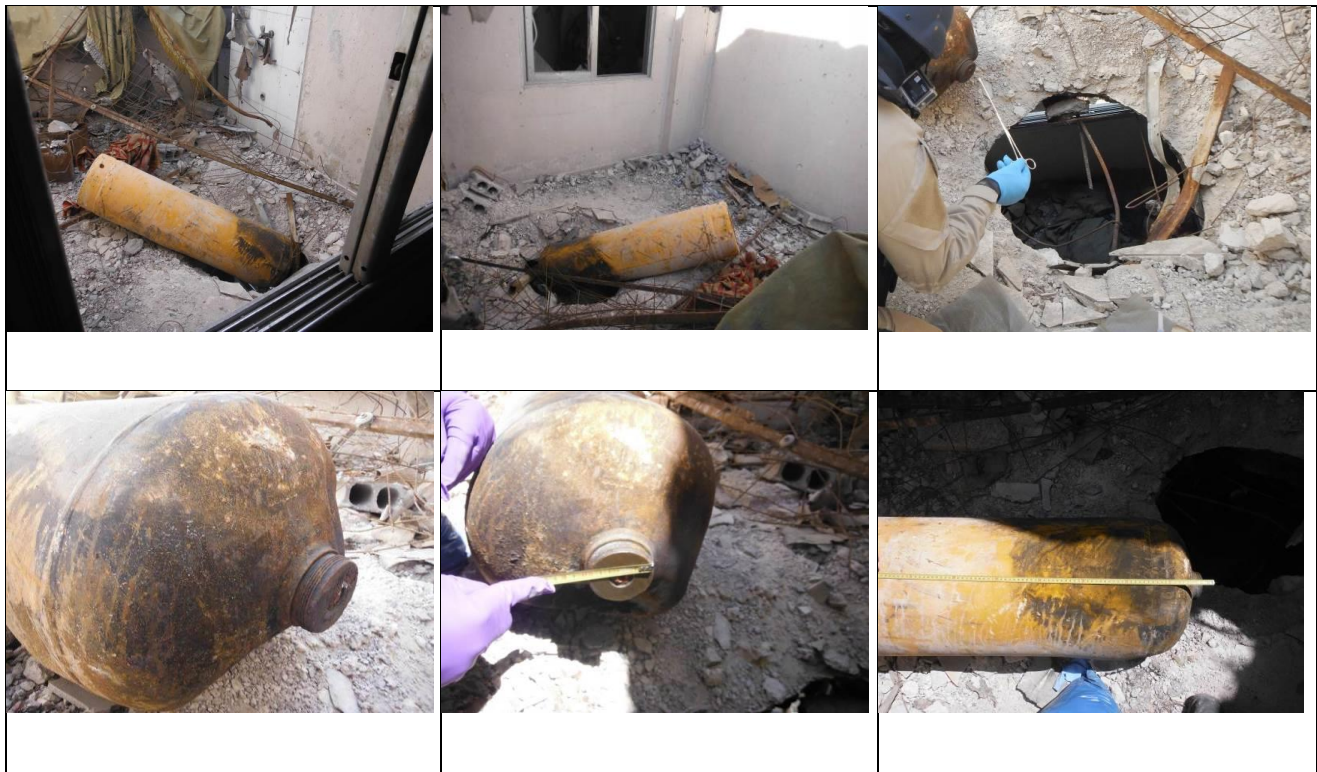
**FIGURE A.6.1 PHOTOS OF TERRACE, CRATER, AND ROOM BENEATH**

11. The aperture observed was circular in shape with approximately 45 degrees angular edges.
12. The mangled ironwork present on the patio indicated that there would have been a metallic frame and mesh covering it at one stage, though it was not clear whether this would have been present at the time of the alleged incident or had been demolished prior to that. The visual damage on the body of the cylinder indicates that the lateral aspect of the cylinder did not slide on the mesh but it hit perpendicularly.

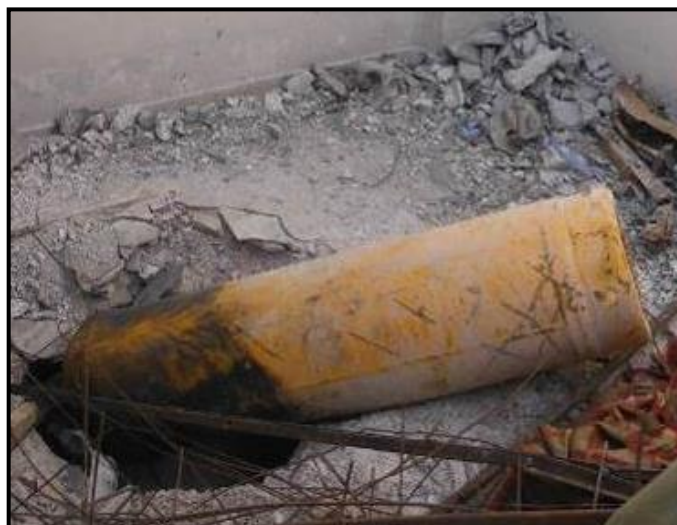
**FIGURE A.6.3 ADJACENT ROOF SHOWING A CRATER SIMILAR TO THE ONE ON THE ROOF TERRACE AT LOCATION 2**

13. The FFM team noted that a similar crater (see photos below) was present on a nearby building.

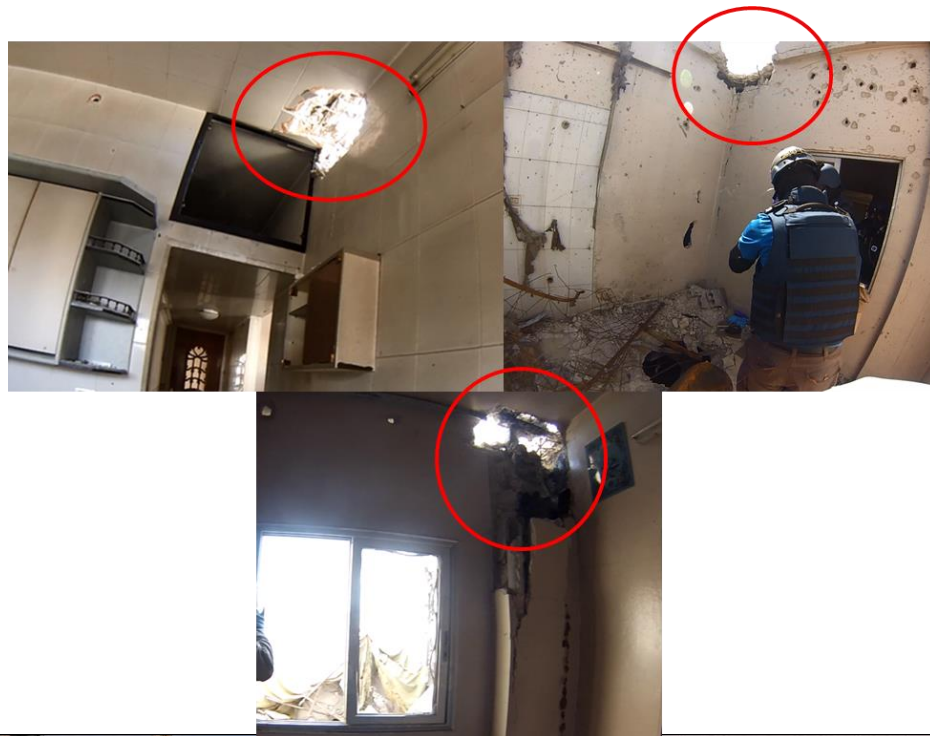
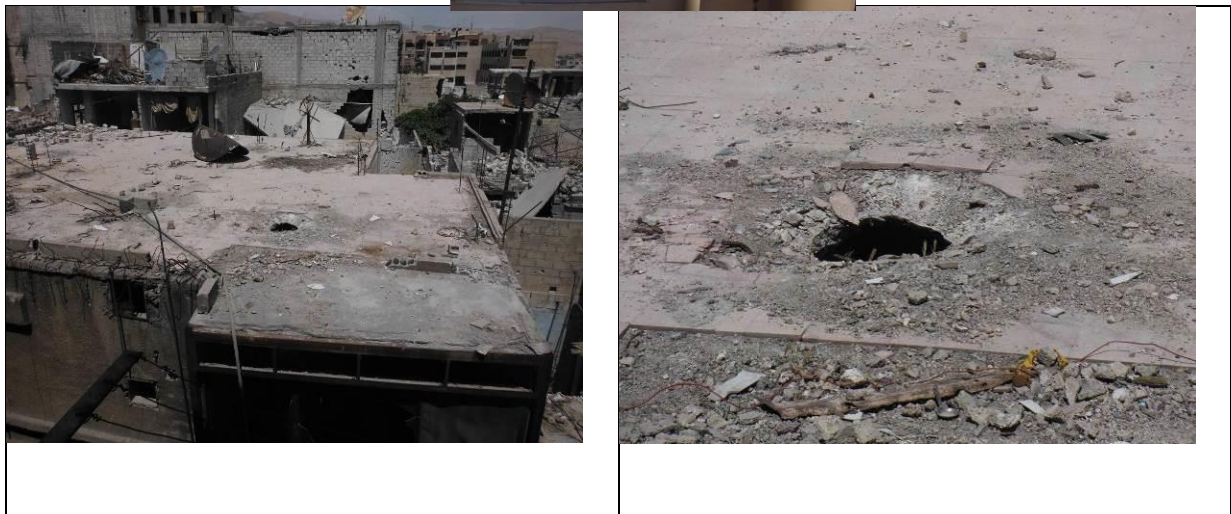
**FIGURE A.6.4 DAMAGE ABOVE THE CRATER OBSERVED FROM DIFFERENT ANGLES**

14. The team was not able to climb on to the top of the building due to the security restrictions, but was able to observe damage in the corner of the balcony location above the crater.

15. Observing the damage on the roof above the crater, the experts were able to provide an explanation of the cylinder not penetrating completely through the aperture. It can be seen that there was a large impact on the roof and walls above the balcony. The impact would decrease the velocity of the falling cylinder and changed

its trajectory while hitting the concrete floor of the balcony causing a hole in it, but without sufficient energy to fall through it.

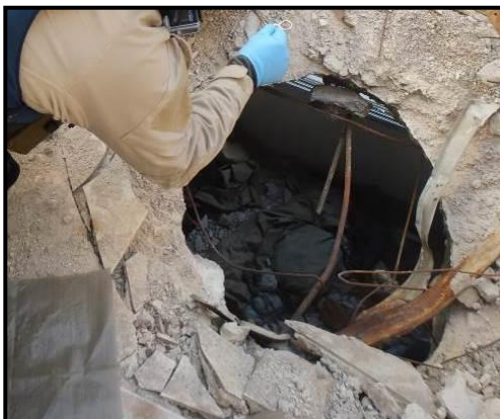
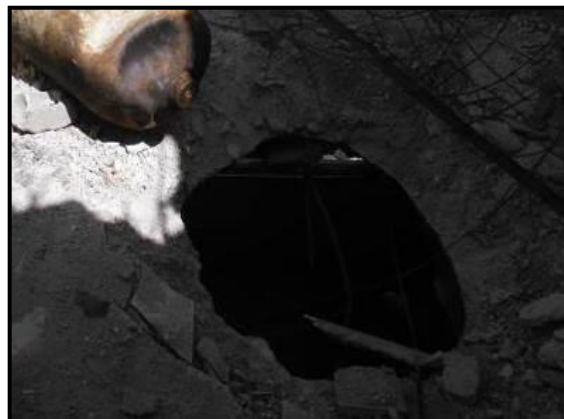
A.6.8 CRATER AS SEEN BY FFM INSPECTORS

crater in order to determine if it had been created by an explosive device. However, this hypothesis is unlikely given the absence of primary and secondary fragmentation characteristic of an explosion that may have created the crater and the damage surrounding it.

17. The FFM team noted the blackening of the ceiling and the rim of the aperture from the room immediately below the point of impact (see photo above). It also noted the blackened sooty walls in the corner of the room, as well as what appeared to be the ashen remnants of a small fire. One interviewed witness stated that a fire had been lit in the room after the alleged incident, reportedly to detoxify it of the alleged chemical.

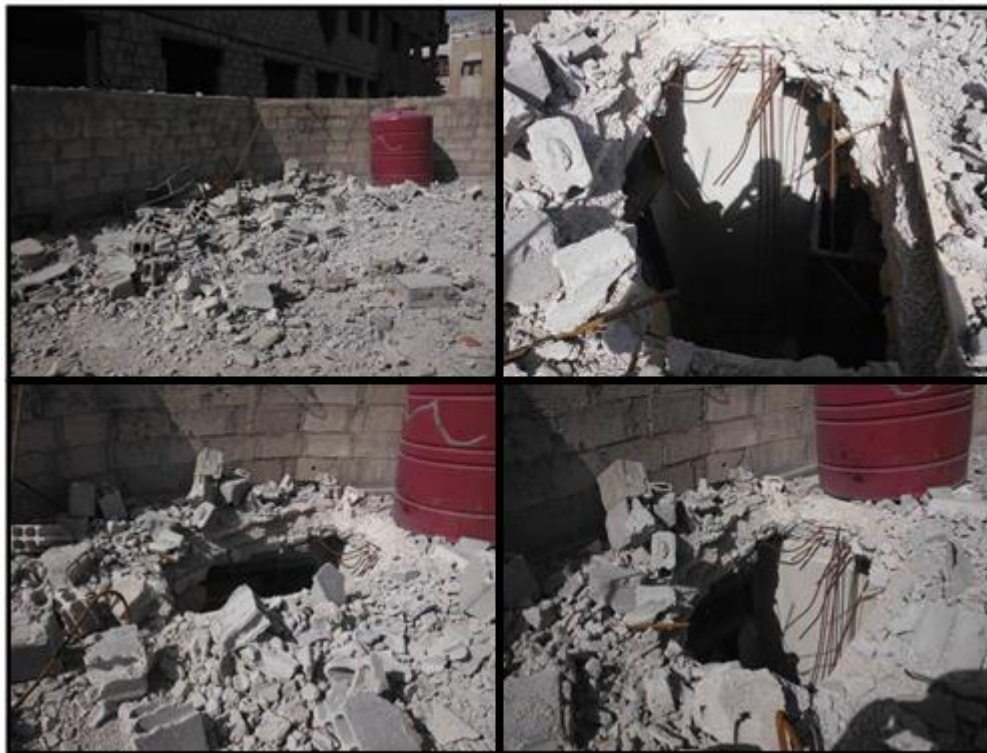
**FIGURE A.7.4 CRATER ON THE ROOF OF LOCATION 4**

The aperture was located close to a surrounding wall and next to the water tank with approximate dimensions of 166 x 105 cm. The distance from the adjacent building varies between 230 cm and 250 cm.

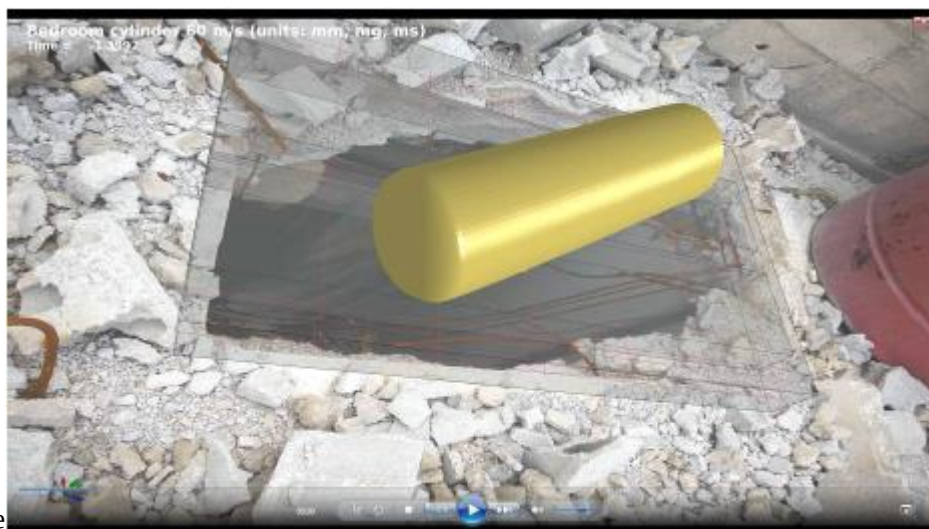
**FIGURE A.7.6 SNAPSHOT OF SIMULATION OF THE POSSIBLE ROOF CRATER FORMATION**

Considering the damage to the wall adjacent to the hole in the roof, it was concluded that the cylinder impacted the roof as shown in Figure A.7.6. From the shape of the crater and damage on the cylinder, it is likely that the cylinder landed parallel to the ground creating a crater with dimensions of approximately 166 x 105 cm, which is in keeping with the dimensions of cylinder of 140 x 35 cm. It should be noted that the cylinder had an additional structure attached to the body, which is still in line with the dimensions of the crater. The damage observed on site by the FFM team and the possible trajectory of the cylinder based on observed damage and numerical calculations are represented in Figure A.7.7.

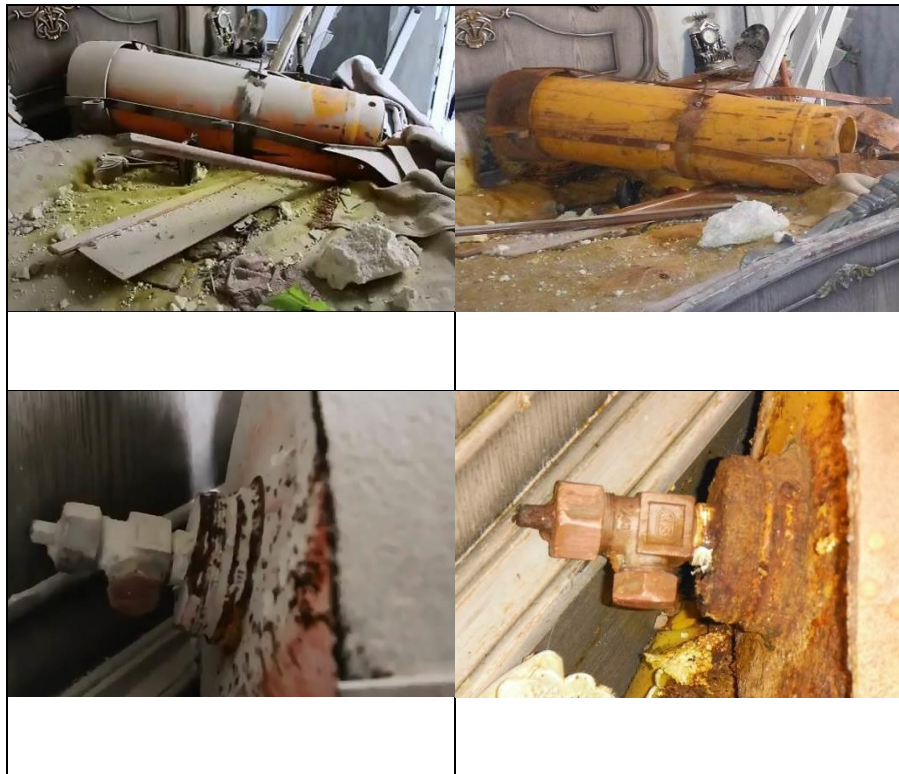
**FIGURE A.7.8 CHANGES IN THE SCENE**

- The cylinder appears to have been cleaned. The layer of a white powder seen in the videos was not present when the FFM team visited the location.

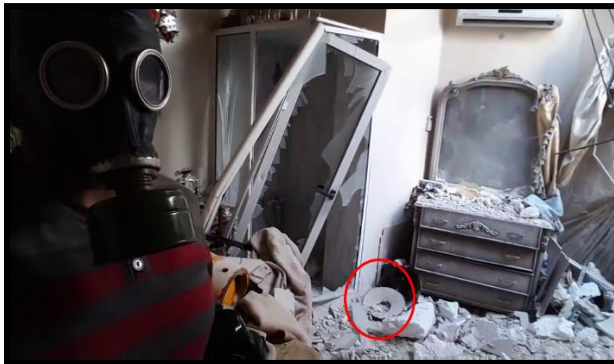
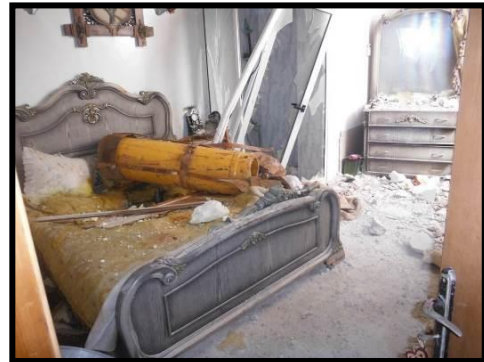
**FIGURE A.7.9 FUNNEL CAP**

- The bedside lamp on the right side (towards the window) had been moved and was also missing in some photos.
- The FFM team observed a viscous liquid throughout the room, which was not apparent in videos. The same liquid was observed also before the entrance to the apartment and on disposable gloves present at the location (Annex 5).
- The round object similar to the funnel cap found at Location 2 was seen on the open source video.

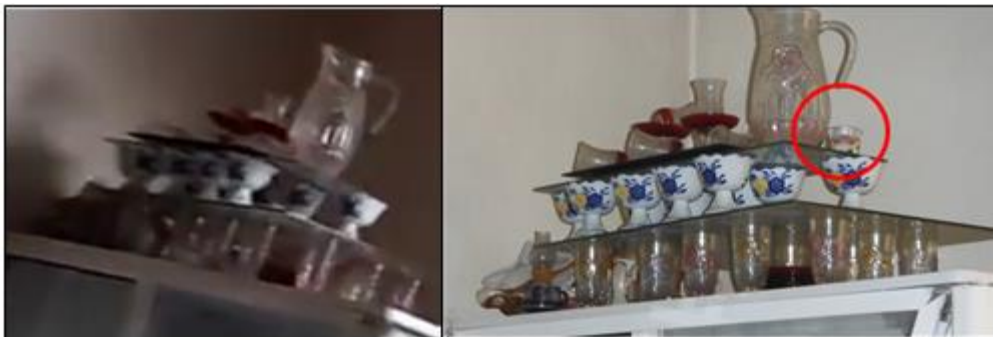
**FIGURE A.7.10 OTHER DISCREPANCIES**

- Another discrepancy observed while comparing open source videos issued before the FFM visit is related to the cup on the shower cabin. In the initial videos, the cup was not present but on the photos and videos taken by the FFM, the cup is visible.

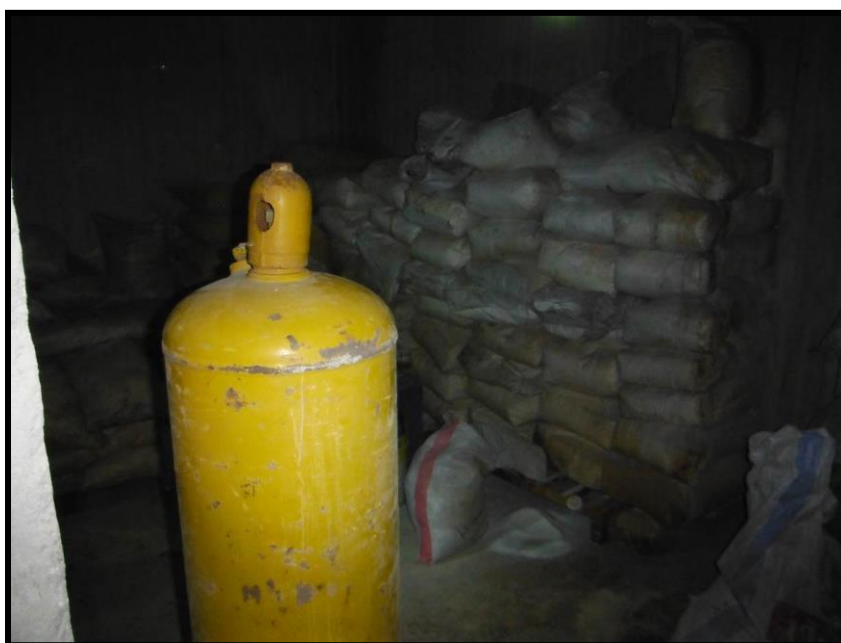
**FIGURE A.8.2 CYLINDER OBSERVED BY THE FFM TEAM AT THE WAREHOUSE**

26. Although the team confirmed the presence of a yellow cylinder in the warehouse, reported in Note Verbale of the Syrian Arab Republic (Annex 10, point 2) as a chlorine cylinder, due to safety reasons (risk involved in manipulating the valve of the cylinder, see Figure A.8.2) it was not feasible to verify or sample the contents. There were differences in this cylinder compared to those witnessed at Locations 2 and 4. It should be noted that the cylinder was present in its original state and had not been altered. Chlorine gas is generally not a common chlorinating agent in the production of chemical weapons agents, except when used in conjunction with phosphorous trichloride, which was not present. Subsequently, the presence of a cylinder reported as containing chlorine gas is not indicative of the production of explosives.
