**Письмо Временного поверенного в делах Постоянного
представительства Соединенных Штатов Америки
при Организации Объединенных Наций от 27 июня 2019 года
на имя Генерального секретаря**

UNCLASSIFIED U.S.
ASSESSMENT OF RECENT INCIDENTS
IN THE PERSIAN GULF

M/V KOKUKA COURAGEOUS Attacked With Iranian Indigenous Extra-Large Limpet Mines (High Confidence)

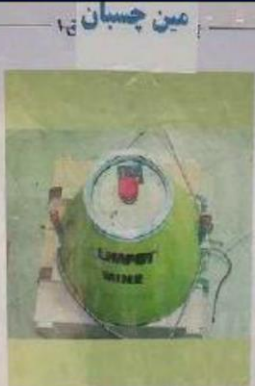
(U) Brochure for Iranian Indigenous Extra-Large Limpet Mine, Publicly Revealed at 2015 Military Display

Project Objectives: This mine has been designed and built to be used against vessels and fixed and mobile metallic and non-metallic structure.

Diameter (mm): 550

Height (mm): 320

Weight (kg): 42

Casing: Aluminum and Composite

Operational Application: To destroy a variety of vessels and fixed and mobile and non-metallic structures.

(U) Brochure for Iranian Indigenous Extra-Large Limpet Mine, Publicly Revealed at 2015 Military Display

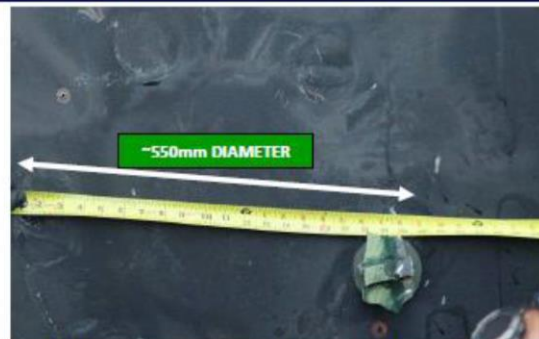
(U) Measurements are consistent with reported diameter of Iranian Extra-Large limpet mine

(U) 14 JUN image of M/V KOKUKA COURAGEOUS (U) Measurements are consistent with advertised Iranian Indigenous Extra-Large Limpet Mine diameter

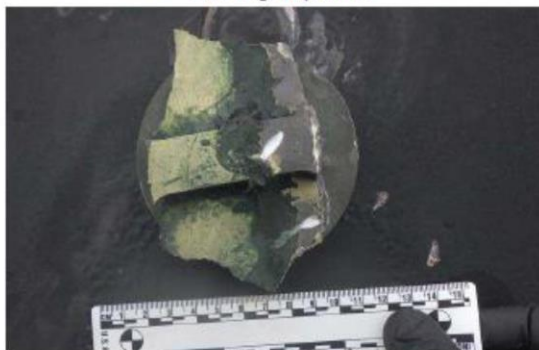
(U) Magnet 3.5" diameter; aluminum, composite remnants

(U) The green composite material on the recovered magnet, location of the cartridge-actuated nail holes, number of nail holes, and diameter of the limpet placement area is consistent with the Iranian "Indigenous Extra-Large" limpet mine advertised in a 2015 arms display. Chemical analysis of collected explosive residue swabs is pending.

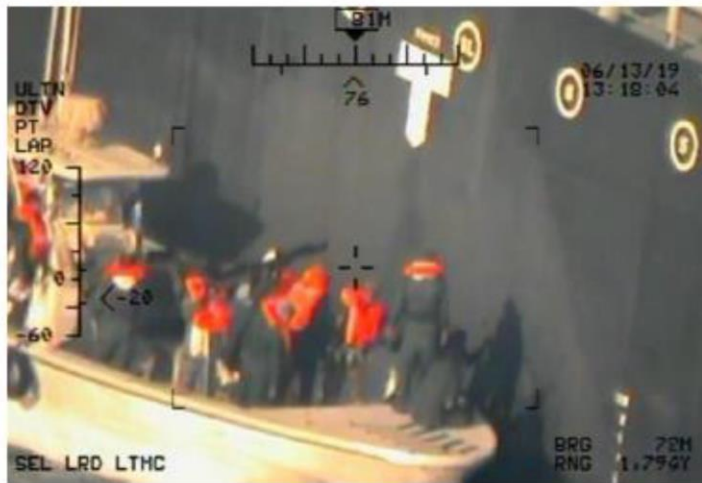
Imagery taken from a U.S. Navy MH-60R helicopter of the Islamic Revolutionary Guard Corps Navy removing an unexploded limpet mine from the M/T Kokuka Courageous.

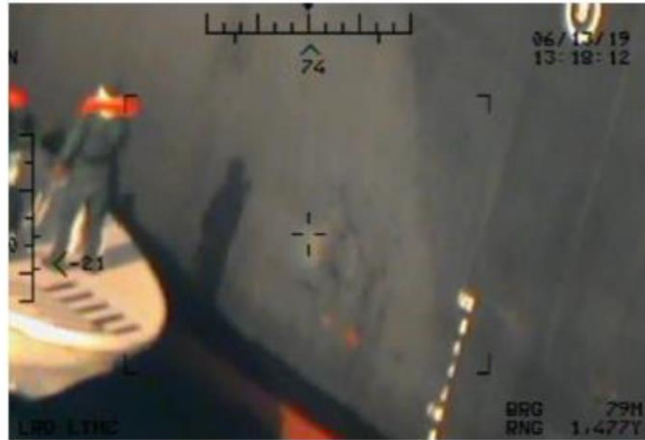
Imagery taken from a U.S. Navy MH-60R helicopter of the Islamic Revolutionary Guard Corps Navy after removing an unexploded limpet mine from the M/T Kokuka Courageous.

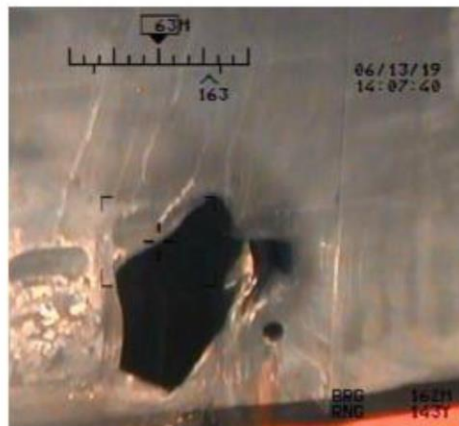
Imagery taken from a U.S. Navy MH-60R helicopter of blast damage to M/T Kokuka Courageous. M/V Kokuka Courageous received damage consistent with a limpet mine attack in the Gulf of Oman, June 13.

The Motor Tanker (M/T) Kokuka Courageous sustained damage from a limpet mine attack while operating in the Gulf of Oman, on June 13th. Limpet mines are attached to a vessel via magnets and/or nails and detonated by a timer. Following the attack, sailors from the Kokuka Courageous discovered a second, unexploded, limpet mine on their vessel and abandoned ship. The Dutch tug Coastal Ace rescued the crew of 21 sailors. The USS Bainbridge (DDG 96) then transferred and transported the Sailors to safety. Later that day, an Islamic Revolutionary Guard Corps (IRGC) Gashti Class patrol boat approached Kokuka Courageous and was observed and recorded by a U.S. Navy MH-60R helicopter removing the unexploded limpet mine from Kokuka Courageous. Iran is responsible for the attack based on video evidence and the resources and proficiency needed to quickly remove the unexploded limpet mine. The hull penetration measures 1.1m at the widest point by 1.5m 4'2" x 3'8" (H x W) at the tallest point. The penetration begins approximately 1m above the water line.

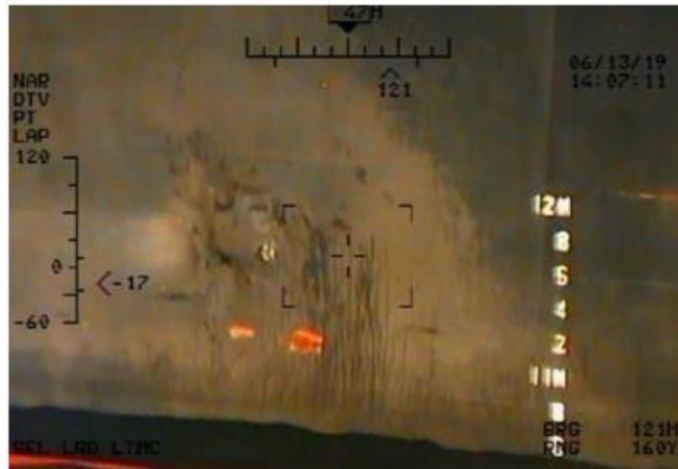
Imagery taken from a U.S. Navy MH-60R helicopter of the Islamic Revolutionary Guard Corps Navy of the remnants of the magnetic attachment device of unexploded limpet mine from the M/T Kokuka Courageous.

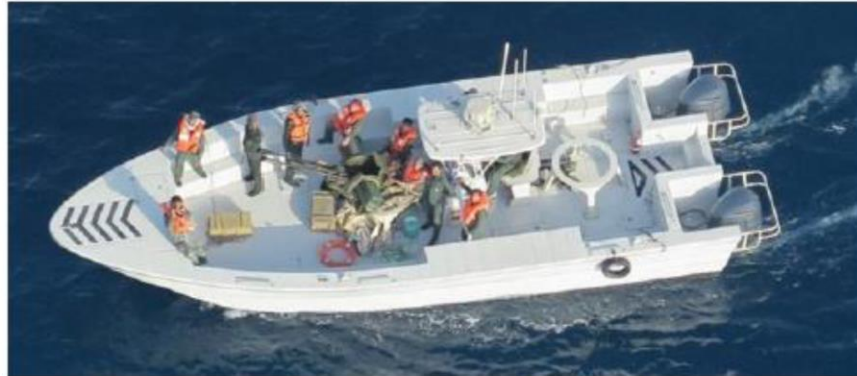
Imagery taken from a U.S. Navy MH-60R helicopter of the Islamic Revolutionary Guard Corps Navy after removing an unexploded limpet mine from the M/T Kokuka Courageous.

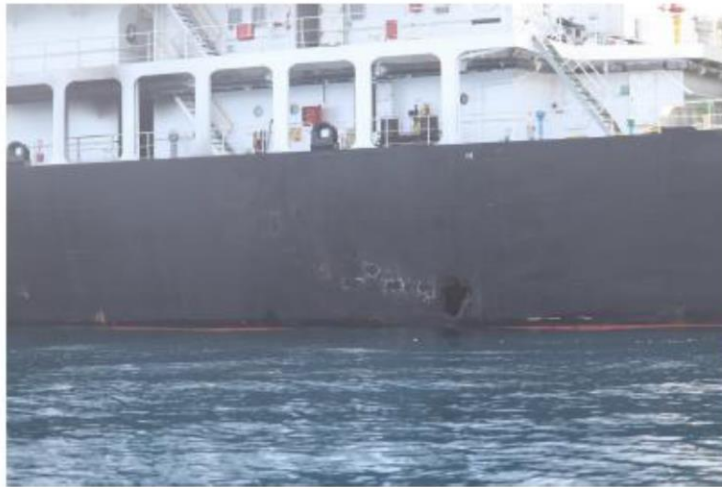
7710 – This is a view of hull penetration/blast damage on the starboard side of motor vessel M/T Kokuka Courageous, which was sustained from a limpet mine attack while operating in the Gulf of Oman, on June 13th.

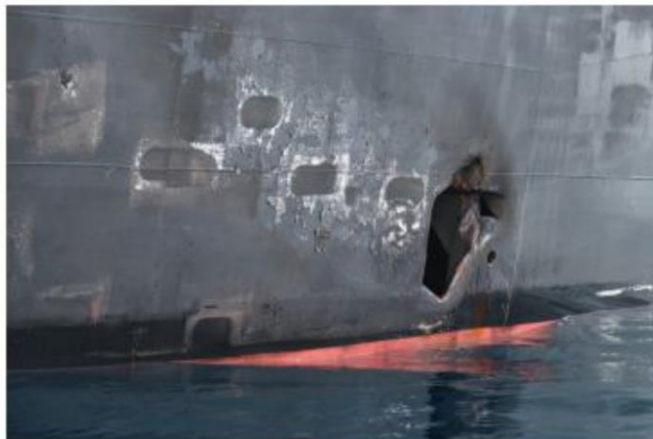
7725 - This photo is a view of hull penetration/blast damage sustained from a limpet mine attack on the starboard side of motor vessel M/T Kokuka Courageous, while operating in the Gulf of Oman, June 13.

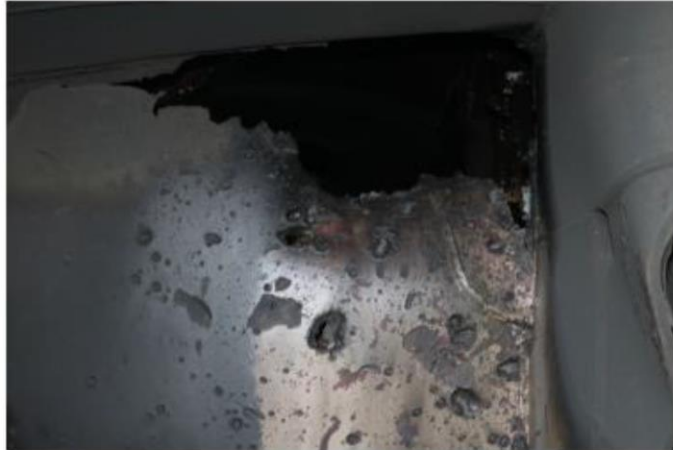
7729 - This photo is a view of internal hull penetration/blast damage sustained from a limpet mine attack on the starboard side of motor vessel M/T Kokuka Courageous, while operating in the Gulf of Oman, June 13.

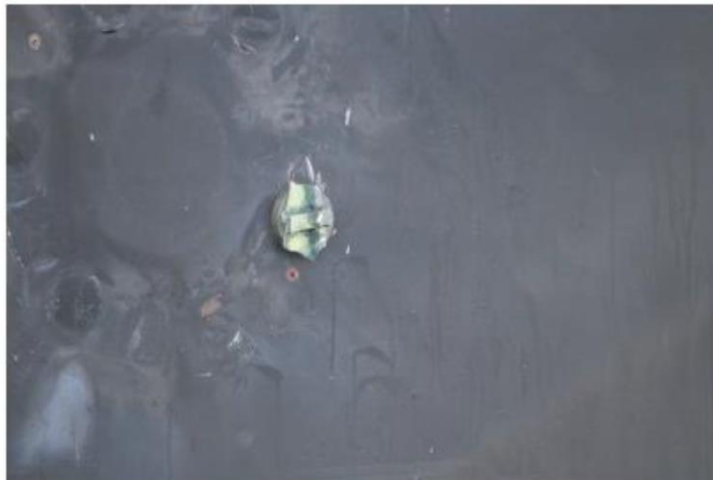
7714 - This is the view of the remnants of a removed limpet mine's placement, location, and damage sustained from a limpet mine attack, on the starboard side of motor vessel M/T Kokuka Courageous, while operating in the Gulf of Oman, June 13. A limpet mine is attached to a vessel via magnet and/or nails. The holes seen were created by nails used to hold the mine in place.

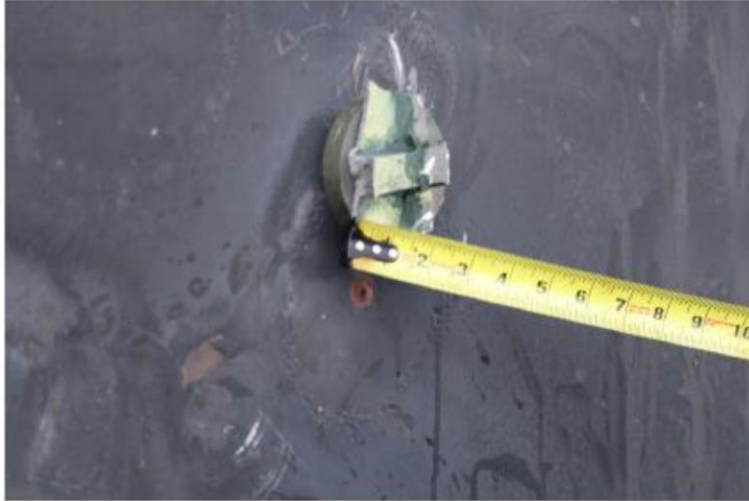
7761 -This photo depicts the aluminum and green composite material left behind following removal of an unexploded limpet mine used in an attack on the starboard side of motor vessel M/T Kokuka Courageous, while operating in the Gulf of Oman, June 13th.
