# 安全理事会

### 事实调查组关于在阿拉伯叙利亚共和国的杜马发生的将有毒化学品用作武器的指称事件（2018 年 4 月 7 日）的报告

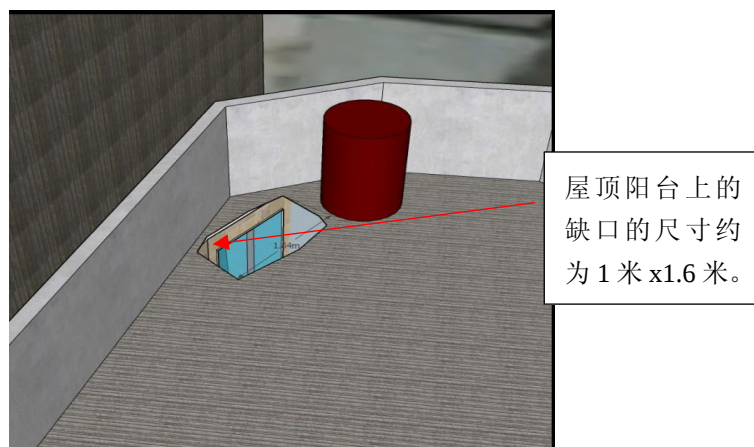
图 7：电脑生成的关于屋顶阳台上的缺口的视图

- 8.28 事实调查组对在屋顶平台上的气罐、缺口、平台和平台周围以及缺口正下方的房间拍摄了若干张照片。调查组记录下了在钢筋混凝土屋顶上的缺口的尺寸以及气罐本体的损毁情况。
- 8.29 调查组分析了现有的材料，并咨询了机械工程、弹道学和冶金学领域的独立专家。借助专用电脑建模技术，那些专家对在 2 号地点发现的气罐的轨迹和损坏情况作了称职和胜任的评估。
- 8.30 对于钢制气罐对钢筋混凝土板的撞击，专家提供了有关报告和数字模拟情景，其中反映了事实调查组在杜马发现的现场状况。分析的结果包含：一般性介绍、几何数据、弹道

- 8.31 分析表明：第 2 号地点的钢筋混凝土平台遭受的结构性损坏是由物体撞击所致，该物体具有对称的几何形状，并具有足以造成观察到的损坏的动能。分析结果显示：所观察到的位于屋顶平台的气罐、缺口、阳台、周围房间、下方的房间和上层的结构遭受的损坏均符合该地点所见的气罐在平台上新造成的缺口的大小。

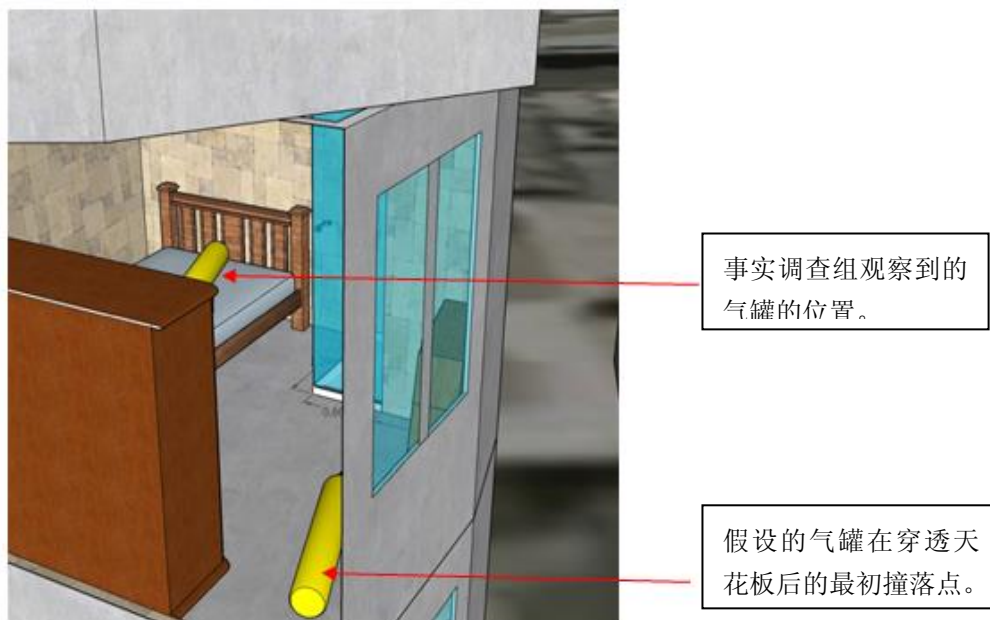
图 11：关于卧室和气罐位置的视图

- 8.32 调查组于 4 月 25 日部署到了第 4 号地点（北纬 33° 34' 20.5"、东经 36° 24' 02.8"），并在那里还拍摄了照片、进行了测量并获取了侦检度数。此外，调查组采集了一大批样品。对被指称的气罐贯穿的屋顶阳台以及据信气罐在其中到达最终落点的房间进行了拍照和测量。附件 7 载有关于结果和分析的进一步详情。
- 8.33 从调查组观察到的情况看，在调查组查访该地点时，气罐似乎没有发生任何泄漏。调查组注意到在床上的气罐下方的有一长块的木头。调查组将这块木头的一部分作为样品带走。这块木头既潮湿又绵软。调查组在房间内用侦检设备进行了检测，但没有发现氯气。实验室的分析表明在所有带回的木头样品中，这块木头样品中的氯化有机化合物的含量最高。

8.34 调查组咨询了机械工程、弹道学和冶金学方面的专家，以请他们对为气罐的轨迹进行称职和胜任的评估。评估的结果表明：在调制下生成的缺口的形状与视察组观察到的形状和损坏情况吻合。评估进一步显示：在穿透屋顶并以低速撞到地板上后，气罐继续改变了滚动轨迹，直至滚到了其被发现的位置。

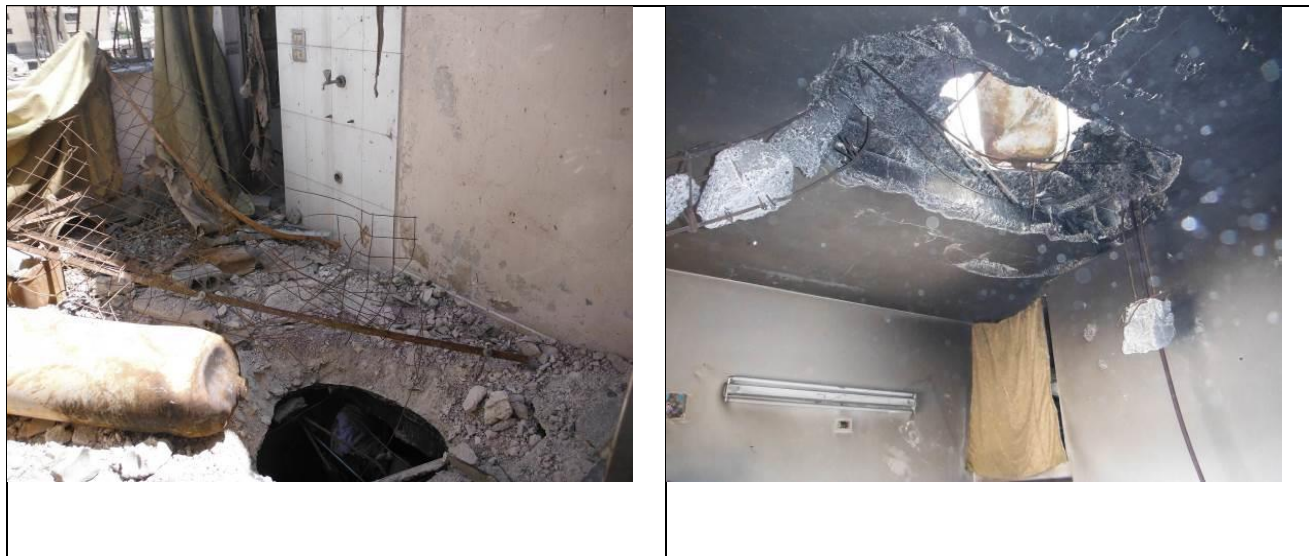
11. The aperture observed was circular in shape with approximately 45 degrees angular edges.
12. The mangled ironwork present on the patio indicated that there would have been a metallic frame and mesh covering it at one stage, though it was not clear whether this would have been present at the time of the alleged incident or had been demolished prior to that. The visual damage on the body of the cylinder indicates that the lateral aspect of the cylinder did not slide on the mesh but it hit perpendicularly.

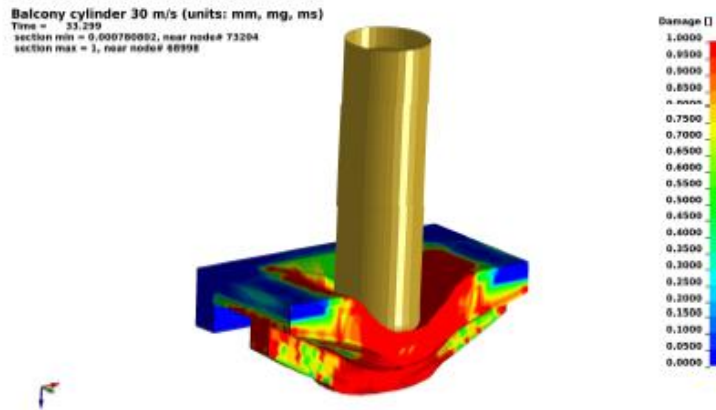
FIGURE A.6.7(b) DAMAGE ON THE CEILING IN THE CASE OF LOW SPEED IMPACT

Red colour indicates zone of complete disintegration

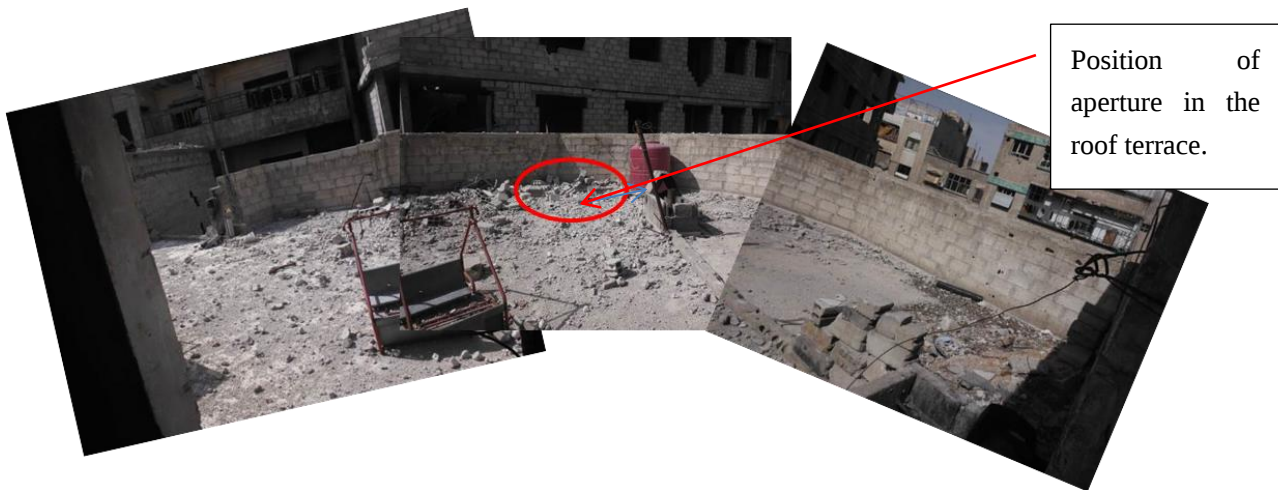
**FIGURE A.7.3 ROOF OF LOCATION 4**

The aperture was located close to a surrounding wall and next to the water tank with approximate dimensions of 166 x 105 cm. The distance from the adjacent building varies between 230 cm and 250 cm.
